16555A-02

S	Е	R	V	I	С	Е	Ν	0	Т	Е
							SUPERSEDE	S: None		
165	55A Deep	o Memor	y Logic	Analyz	er Modu	ule				
Ser	Serial Numbers: US34070101/US34070200									
Ma	ster/Expa	ander op	eration i	mprov	ement					
То	Be Perfor	med By:	: Agilent	-Qualif	ied Perso	onnel				
Par	ts Requi	red:								
	t No.			escripti						
165	55-66503		Ci	rcuit B	oard					
165 tior boa <b>Sol</b> 165 with mut	ns do not r rd multica ution/Act 55A circu h the upda	eliably op ard config ion: hit boards ated 1655 aster and 2	perate in gurations that have 5-66503 2 expand	master have b e five r board. er boar	/expande een foun master/ex The upo rds (three	er multicar Id to produ pander bo lated 1655	ive-board multic d configurations ace incorrect dat ard connectors 1 5-66503 board s ilticard configur	s. Four- a a to the u must be re supports a	eplaced a maxi-	
								C	Continued	,
							DATE: Octobe	er 1995

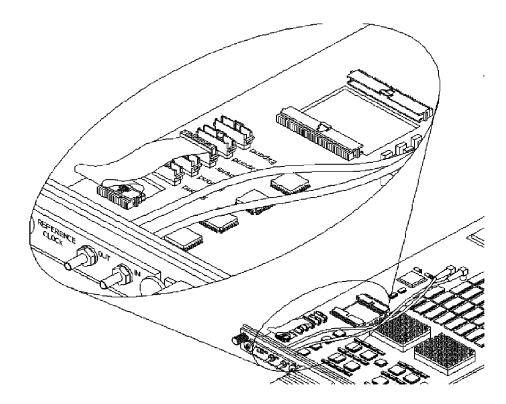
Identify a suspect board by observing the number of expander board connectors on the circuit board as shown in the following figure.

If five connectors are present (J4-J8), then the board requires replacement. Order a replacement board using the 16555-66503 part number. Follow the procedures in the 16555A service manual to perform the replacement. The replacement board does not require calibration.

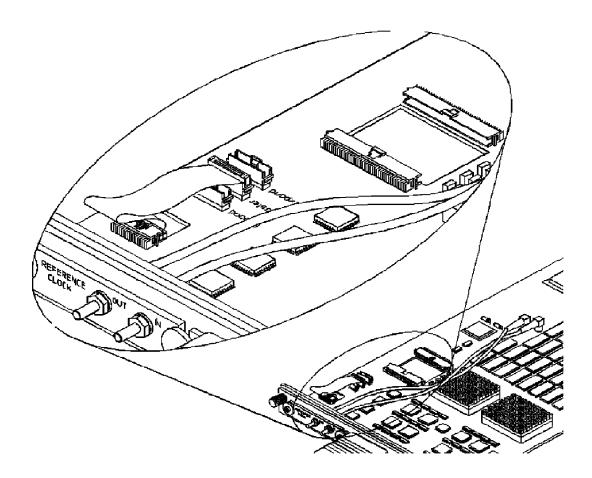
If only three connectors are present (J5-J7) as shown in the following figure, then the board is not to be replaced.
