S E R V I C E N O T E

Agilent Medalist i3070 In-Circuit Test System

Changes to Control XTP card Firmware due to change in old NEC 4Mx4bit SRAM to new NEC 2Mx8bit SRAM

Rev. 17

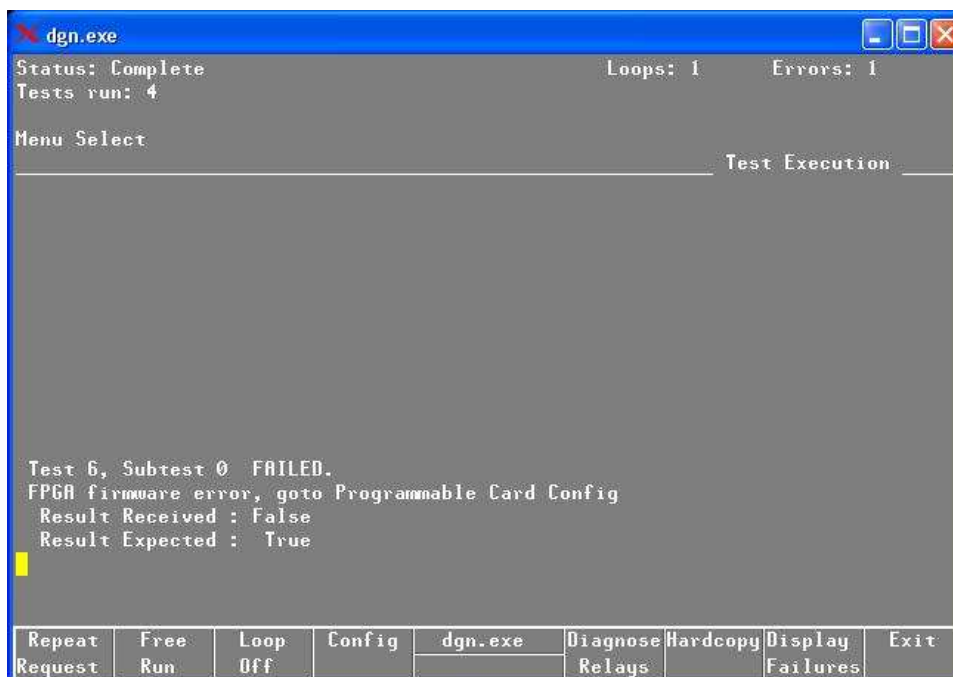
If the wrong firmware is loaded, the Control XTP card will not function correctly. Users who have testheads that installed with Control XTP of one version and software release of another version may detect this differences at failing diagnostics “Test 6, Subtest 0” with the error “FPGA firmware error”. This is a symptom that the firmware versions are different. (See Figure 1)

Figure 1: Diagnostics failure message when wrong firmware is loaded.

C. Program the new firmware into the Control XTP card (one time only process)

- a. Boot up the testhead as described above
- b. Launch the diagnostics application
- c. Click on “Configuration” and click on “Programmable Card Config”
- d. Click on “Update All” (F1) button to program all the Control XTP cards on the testhead.
(Note: Please ensure that the expected value should be **10071517_1** before updating)

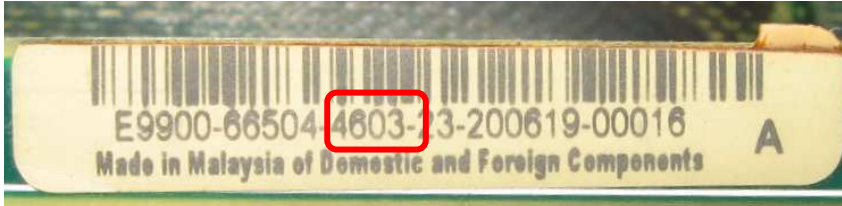
Figure 2: Control XTP card label (installed with old 1818-8683 NEC 4Mx4bit SRAM)

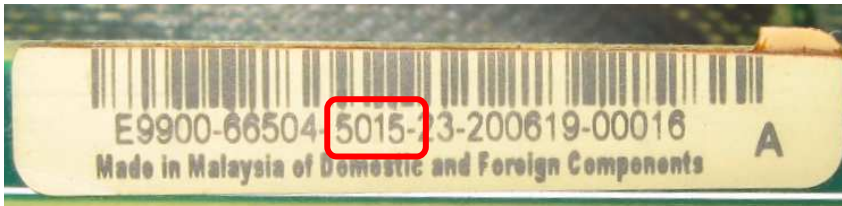
Figure 3: Control XTP card label (installed with new 1819-0563 NEC 2Mx8bit SRAM)

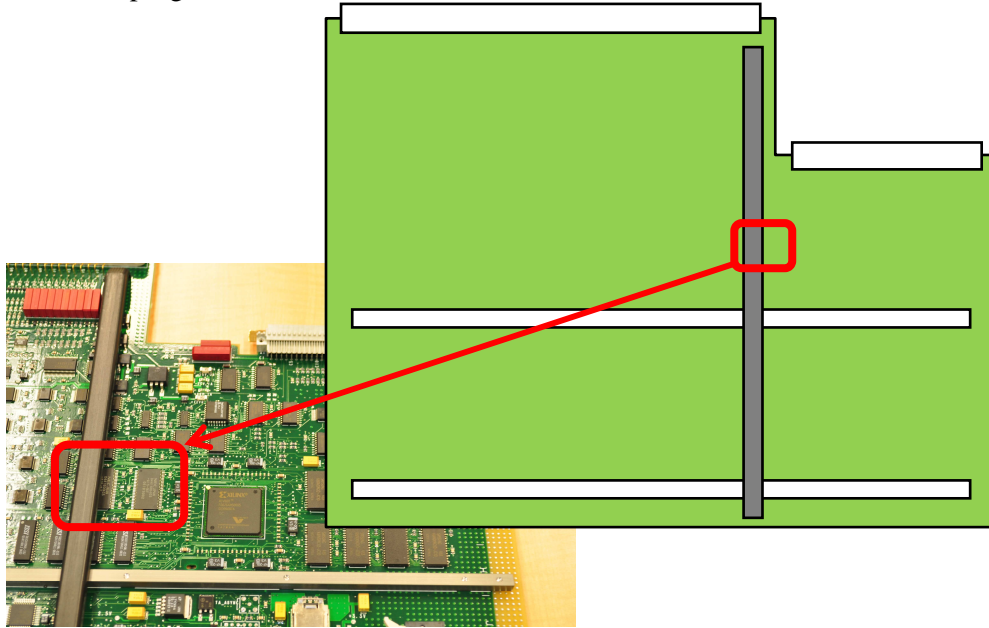
Another way to identify the different SRAMs is from the markings on the IC. The SRAMs can be found near the top right corner of the Control XTP card.

Figure 4: Location of NEC SRAM on the Control XTP Card

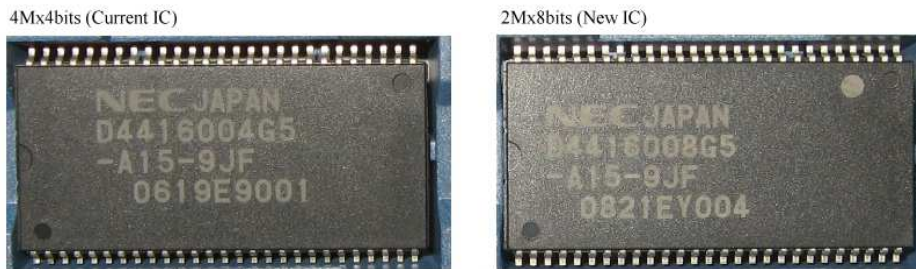
Figure 5: Markings on the NEC SRAMs

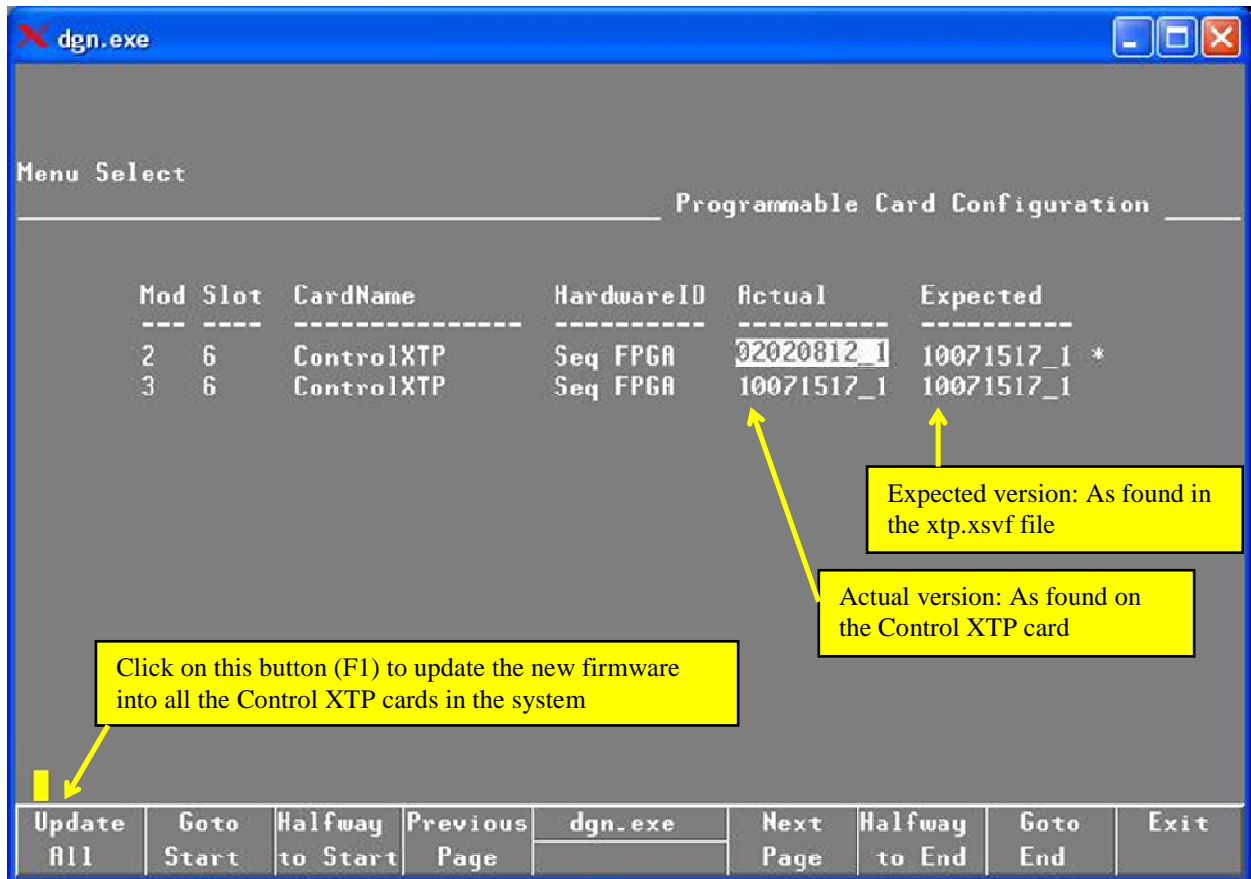
Figure 6: Diagnostics Configuration to update firmware
