3070-88

S E R V I C E N O T E

Agilent Medalist i3070 and i3070 Series 5 In-Circuit Test Systems

Bios 1.12 version in rp5700 causes longer time to load board directory across network

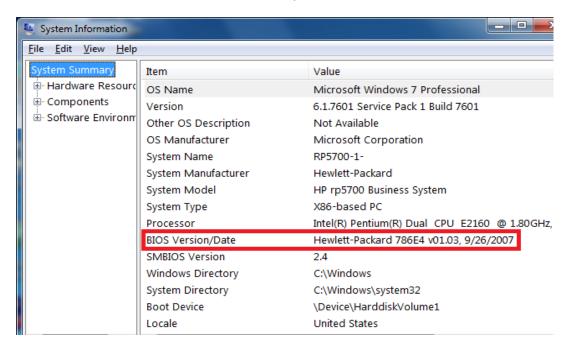
The Hewlett Packard rp5700 PC model may take a longer time to load the board directory or startup "Push Button Debug" if the board directory resides in the network server. The above symptoms occur on the rp5700 that uses **Bios version 1.12**.

You can find the BIOS Version/Date as shown in the figure below. Please follow the steps under the Solution/Action in this service note to update to **Bios version 1.20**.
