3070-89A

Modification Recommended Service Note

Keysight i3070 Series 5 and Series 5i In-Circuit Test System

i3070 test system controller encountered intermittent testhead booting error – i3070 test system controller that uses i3070 09.10p software release may encounter testhead booting issue.

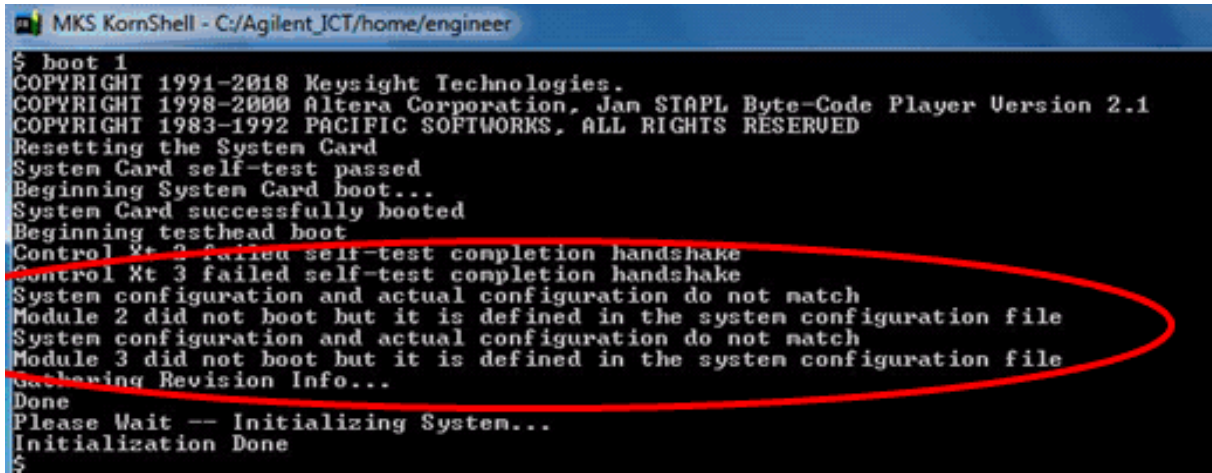
The i3070 Series 5 test system controller that installed i3070 software 09.10p with Windows 7 Operating System may encounter testhead boot-up issue as shown below.

The Bootp Turbo software used in 9.10p is having some conflicts with certain types of PC controller. This could happen to newly shipped systems, or existing systems upgraded from earlier software revision.

Install a newer version of BOOTP Turbo software could resolved the issue.

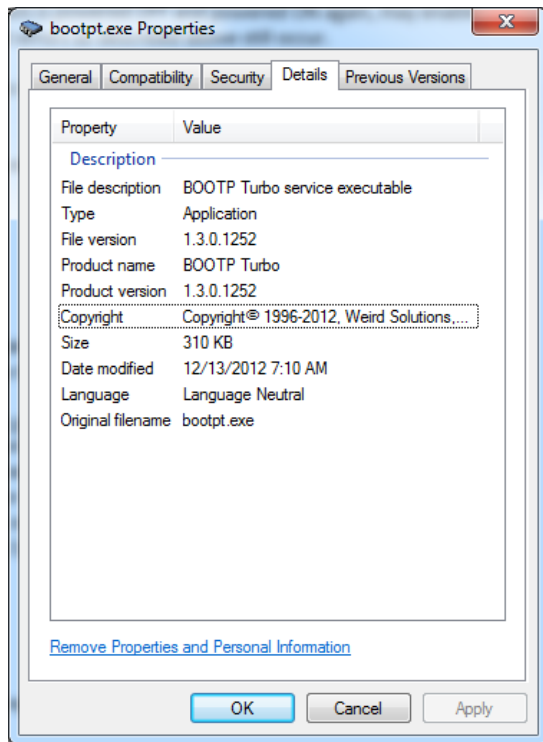
The correct Product version is “1.3.0.1252” and the Copyright is “Copyright@1996-2012”

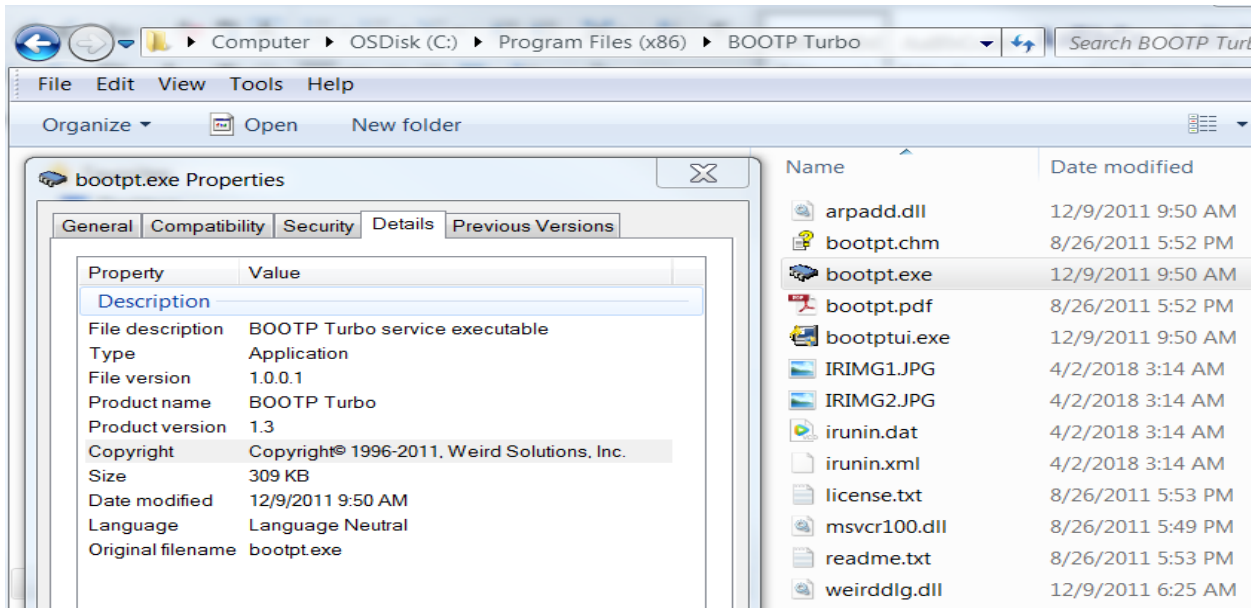
Locate the following file “C:\Program Files (x86)\BOOTP Turbo\bootpt.exe”, right click mouse and select the “Properties”, then select “Details” tab as shown below:

If the Product version is “1.3” and Copyright is “Copyright@1996-2011”, it is recommended to update the BOOTP Turbo software even though the system has not experienced the boot up issue.
