3070 - 95

# Modification Recommended Service Note

## Keysight i3070 Series 5 Inline In-Circuit Test System

**The Problem** – To Prolong life span of Conveyor motor in 2 module Inline ICT.

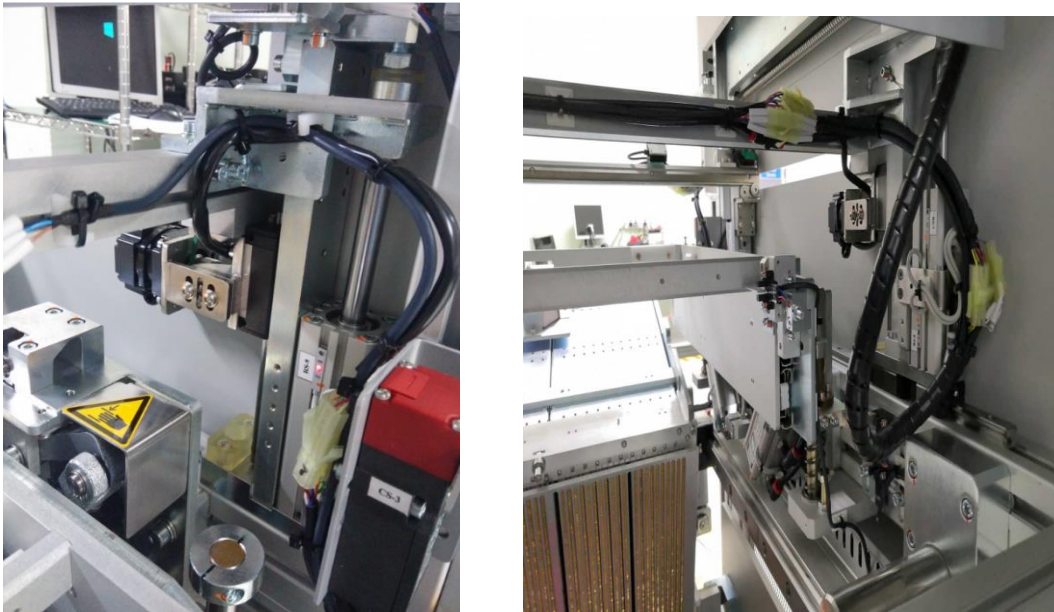
The conveyor up/down motion causing the conveyor motor cable subject to repeated stretching and bending action. When conveyor motor (P/N 3140 – 1139) defective, it is due to cable faulty only. In this case, whole conveyor motor assembly needed to be replaced.

Figure 1: Routing of the additional Flexible cable

In order to prolong the life span of conveyor motor cable, it is recommended to add a flexible cable adapter such that the up/down motion will only stress on the adapter cable only. For hardware maintenance, only replace the conveyor motor adapter cable instead of whole conveyor motor assembly.
