3070-96B

Modification Available Performance Enhancement Service Note

Keysight i3070 Series 5 Inline In-Circuit Test System

The Problem – Remove unused secondary Press of Inline ICT

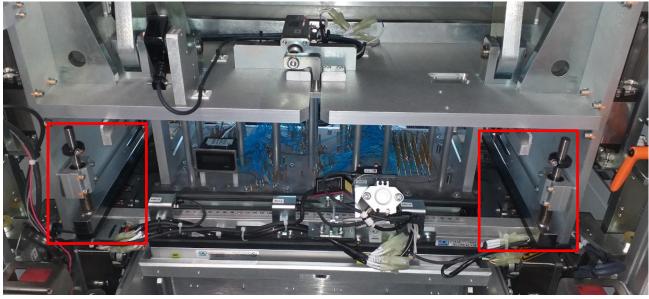
Figure 2: Secondary press during press and test cycle

When the Press moves to "All probe" position, the secondary Press (Figure 2) will have some force acting upon the rails. There is a perception that this force may cause significant impact to the conveyor rails over the longer term.

The secondary press is no longer installed in E9988EL and E9986E systems since June 2019 as it does not serve any functionality. It is therefore advised that the secondary press is removed on existing installed systems.

The PLC firmware should be updated to the latest version following removal of the secondary press.
