3070-98

Modification Recommended Service Note

Keysight i3070 Series 6 In-Circuit Test System

The Problem – Rotation motor switch may damage or stuck for Series 6 In-Circuit Tester

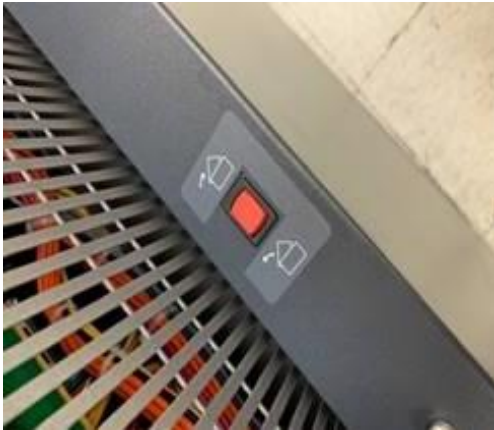
The rotation motor switch may damage or stuck after system was installed. The problem re-surfaced again after the rotation motor switch (Part Number: 3101-3286) was replaced.

The opening area of POD Cover S6, Right may accidentally latch on the rotation motor switch (Figure 1) if the POD cover didn't lift-up substantially during removing and installation. The latched-on will cause the rotation motor switch to weaken after long hour of operation.

Figure 1: Origin design of POD Cover S6, Right

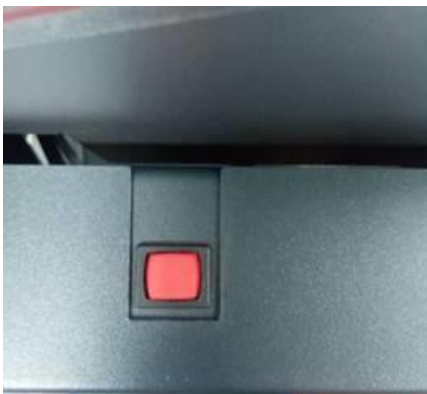
Figure 2: New design of POD Cover S6, Right

The POD Cover has been re-designed (Figure 2) to prevent damage to the rotation motor switch during installation or remove even though it wasn't lift-up substantially. The problem was fixed after newer design POD Cover S6, right (Part Number: E9900-00322) has been installed.

The new POD Cover was implemented on new system since June 29, 2020.
