34460A-08

Modification Recommended Service Note

34460A Digital Multimeter, 61/2 Digit

The Problem – Failure due to front panel loose issue.

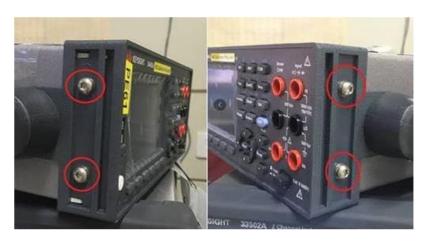
A loose front panel could cause communication error between front panel board and main board. When this happens, instrument might exhibit the following failure/error message:

The failure caused by a loose front panel can be resolved by securing the front panel with 2 screws and washers at both sides of the front panel.

- 1. Order the required parts.
- 2. Remove and then reassemble the front panel.
- 3. Secure the front panel with 2 screws and washers at each side of the front panel.
