34465A-06

# Modification Recommended Service Note

# 34465A Digital Multimeter, 61/2 Digit

The Problem – Failure due to front panel loose issue.

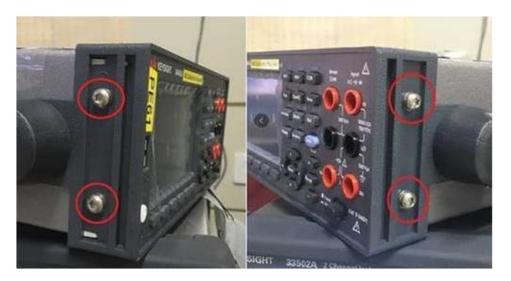
A loose front panel could cause communication error between front panel board and main board. When this happens, instrument might exhibit the following failure/error message:

The failure caused by a loose front panel can be resolved by securing the front panel with 4 screws and 4 washers at both sides of the front panel.

- 1. Order the required parts.
- 2. Remove and then reassemble the front panel.
- 3. Secure the front panel with 2 screws and washers at each side of the front panel.
