34901A-07

# Modification Recommended Service Note

## 34901A Armature Multiplexer Module for 34970A/72A, 20-Channel

The Problem – Hard or too tight to insert the module into 34970A/34972A

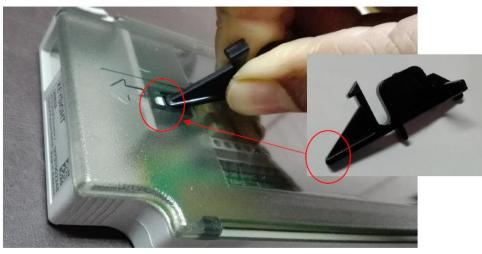
34901A module within the serial number may experience hard or too tight to insert into 34970A/34972A main frame. The top cover width and thickness dimension were out of specifications.

1. Use the terminal latch (34401-45012) to open the top cover by pressing the latch. Do not use hard piercing or sharp object to open the top cover to avoid cover scratches.
