34980A-06

Modification Recommended Service Note

34980A Multifunction Switch/Measure Unit

Serial Numbers: MY56482363 - MY56484193, SG564680019 - SG56480030

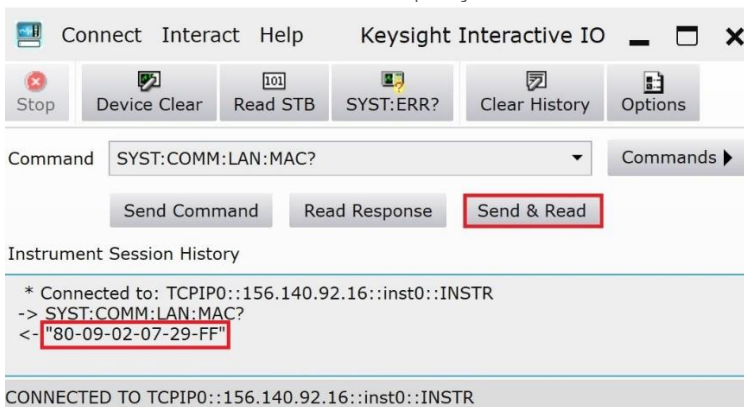
Media Access Control (MAC address) is a hardware address that uniquely identifies each instrument on a network. Each of the 34980A instruments must have a unique MAC address. Due to a software bug, some 34980A's have been shipped with the same MAC address [80-09-02-07-29-FF]. When 34980A's that have the same MAC address are connected to the same local area network, an IP conflict occurs.

3. Launch Keysight Interactive IO tool within Connection Expert and verify the MAC address of the instrument using SCPI command:
(a) "SYST:COMM:LAN:MAC?" : query the instrument's LAN MAC address.
