## S E R V I C E N O T E

**4195A Network/Spectrum Analyzer****Serial Numbers:**

**Modification to cure the problem of “No signal for spans less than 2.4 MHz”****Duplicate Service Notes:** None**To Be Performed By:** Agilent-Qualified Personnel**Parts Required:**

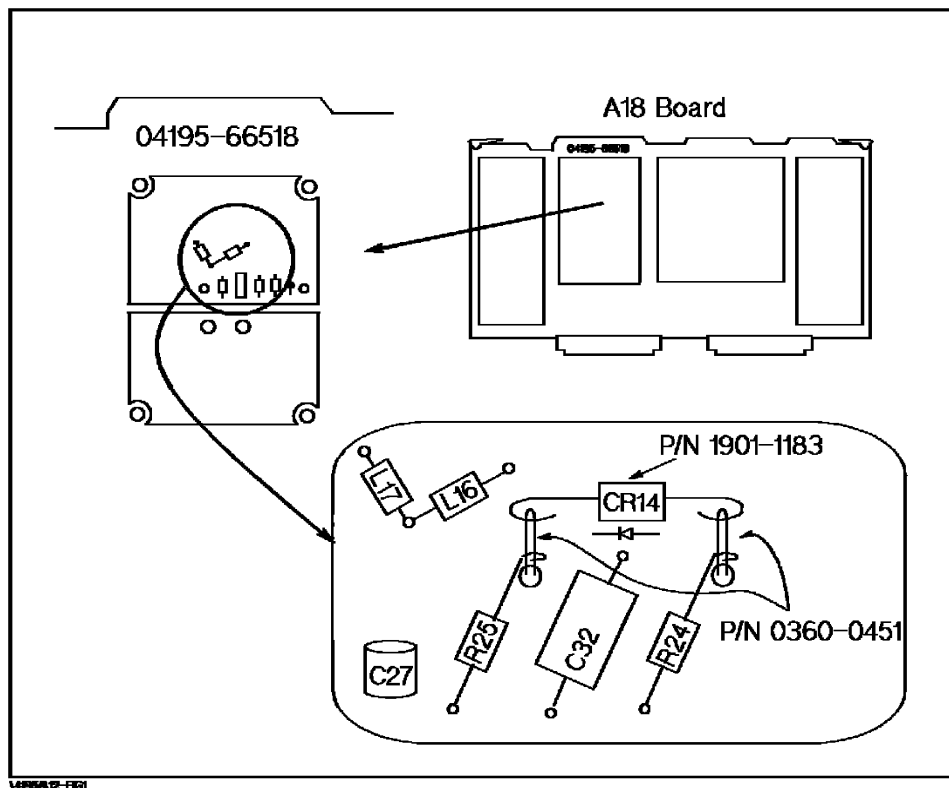
Figure 1. A18 Board Modification

When the 4195A within the listed serial number range is turned on or when it sweeps the frequency with the frequency span less than 2.4 MHz, the phase locked loop may not work properly and the test signal may disappear.

1. Remove the top cover and the shield plate.
2. Remove the A18 board.
3. Remove one lead each of A18R24 and A18R25. See Figure 1.
4. Insert two TERM-SGL-PINS (P/N 0360-0451) from the component side into one-side-holes of A18R24 and A18R25. Solder the two pins.
5. Wrap the leads of A18R24 and A18R25 on the corresponding pins mounted in the holes for A18R24 and A18R25.
6. Wrap the leads of new DIODE (P/N 1901-1183, A18CR14) between the two pins. (Wrap the CATHODE lead of the DIODE to the pin of A18R25 and the ANODE lead to the pin of A18R24).
7. Solder the DIODE and A18R24/A18R25 mounted on the two pins.
8. Reinstall the A18 board.
9. Reinstall the shield plate and the top cover.
