4352	2B-08	s-S
	S	Е	R	V	I	С	Е		Ν	0	Т	Е
	_			CO/PLL	_				SEDE	S: None	9	
	Serial Numbers: JP1KE00101 / JP2KE00624											
					WA	RNI	NG					
		A br	roken A	AC inlet ma	ay poten	ntially 1	esult in a	electric	e shoc	k hazard	l .	
	To Be Performed By: Agilent-Qualified Personnel											
	Parts	s Require	d:									
	Agile	ent P/N	D	escription	Qty		Memo					
	5080 0435	-4112 (*) -3270 2-00243 -1303	L R	ilicon Seal abel ear Panel use	1 1 1 1	Se Se	olution 1 olution 1 olution 2 olution 2					
	(*) S	tore in a co	ool, dry	place out o	of direct	sunligh	ıt.					
											Continue	d
							C	DATE: S	Septer	mber 200	00	
ADN	MINIST	RATIVE	INFO	RMATION	١							
SERVICE NOTE CLASSIFICATION: PRIORITY SAFETY												
ACTI CATE	ION EGORY:		IMM	EDIATEL	Y	-	NDARDS: .5 Solution #	1 or 2.0 S	olution	#2 hours I	LABOR	
			_			1		_		1

SERVICE NOTE CLASSIFICATION:								
PRIORITY SAFETY								
ACTION CATEGORY:	IMMEDIATELY	STANDARDS: 0.5 Solution #1 or 2.0 Solution #2 hours LABOR						
LOCATION CATEGORY:	ON-SITESERVICE CENTER	SERVICE □ RETURN USED □ RETURN INVENTORY: □ SCRAP PARTS: ■ SCRAP □ SEE TEXT □ SEE TEXT						
AVAILABILITY:	ALWAYS	AGILENT RESPONSIBLE UNTIL : ALWAYS						
AUTHOR: HU	ENTI

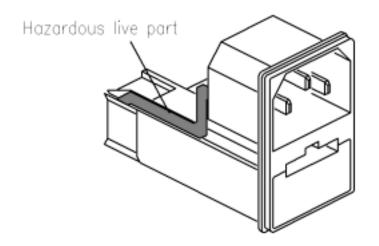
Figure 1 AC Inlet Connector

The AC inlet (P/N 1252-6951) has the potential to slip out of the instrument's rear panel slot if the AC power cord is forcefully pulled in a diagonal direction. When this happens, an exposed connection on the AC inlet module may touch the rear panel of the instrument and cause an electrical short if the AC power cord is still connected to the AC power outlet. See Figure 1.

In the worst case, there is also a possibility of an electric shock hazard to the user if the user completes a circuit between the instrument panel and another grounded connection while the AC power cord is still connected to the AC power outlet.

Solution 1. AC Inlet Still Intact.

- Remove the AC power cable from the AC power outlet and the product.
- Remove the top, bottom, and side covers.
- Seal the hot line terminal on the AC inlet with silicon paste (P/N 5183-4112).
- Reinforce the connection between the AC inlet and the rear panel with silicon paste.
- Perform Self Test to verify instrument operation.

Solution 2. AC Inlet Broken

- Remove the AC power cable from the AC power outlet and the product.
- Remove the top, bottom, and side covers.
- Replace the rear panel assembly with P/N 04352-00243.
- Install the new fuse P/N 2110-1303.
- Perform Self Test to verify instrument operation.
