# S E R V I C E N O T E

## Agilent 4395A Network/Spectrum/Impedance Analyzer

Serial Numbers: JP1KE00101 / JP1KE01402

Page 2 Service Note 4395A-09-S

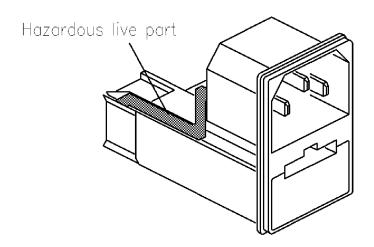
Figure 1. AC Inlet Connector

The AC inlet (P/N 1252-6951) has the potential to slip out of the instrument's rear panel slot if the AC power cord is forcefully pulled in a diagonal direction. When this happens, an exposed connection on the AC inlet module may touch the rear panel of the instrument and cause an electrical short if the AC power cord is still connected to the AC power outlet. See Figure 1.

In the worst case, there is also a possibility of an electric shock hazard to the user if the user completes a circuit between the instrument panel and another grounded connection while the AC power cord is still connected to the AC power outlet.

### **Solution 1. AC Inlet Still Intact.**

- Remove the AC power cable from the AC power outlet and the product.
- Remove the top, bottom, and side covers.
- Seal the hot line terminal on the AC inlet with silicon paste (P/N 5183-4112).
- Reinforce the connection between the AC inlet and the rear panel with silicon paste.
- Perform Self Test to verify instrument operation.

### **Solution 2. AC Inlet Broken**

- Remove the AC power cable from the AC power outlet and the product.
- Remove the top, bottom, and side covers.
- Replace the rear panel assembly with P/N E4970-00223.
- Install the new fuse P/N 2110-1303.
- Perform Self Test to verify instrument operation.
