S E R V I C E N O T E

4396B Network/Spectrum Analyzer

Power Supply may fail due to it's design.

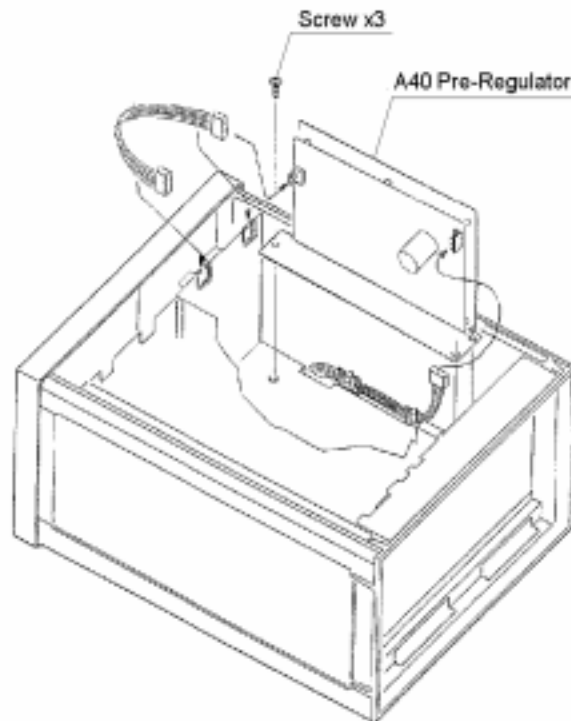
4396B Replace A40 Pre-Regulator

The Power Supply (A40 Pre-Regulator) may fail due to a problem in its design by a 3rd company. This problem most likely happens when the line switch is cycled on and off quickly while the unit is warm.

1. Remove the two feet located on the top of the rear panel.
2. Remove the top cover.
3. Remove the shield plate.

4. Disconnect the two connectors.
5. Remove the A40 Pre-Regulator.
6. Replace the new A40 Pre-Regulator.
7. Connect the two connectors.
8. Replace the shield plate, the top cover, and two feet.
