**44470A-01****S E R V I C E                      N O T E**Supersedes:  
NONE**44470A** 10 channel multiplexer module for 3499A/B. Includes a screw terminal block**44471A** 10-channel General Purpose Relay for 3499A/B. Includes a screw terminal block**44473A** 4x4 Matrix Module for 3499A/B. Includes a screw terminal block**44474A** 16-bit Digital I/O Module for 3499A/B. Includes a screw terminal block**Serial Numbers:**

April 23, 2008

**Defective connectors shipped with 44470A, 44471A, 44473A, 44474A**

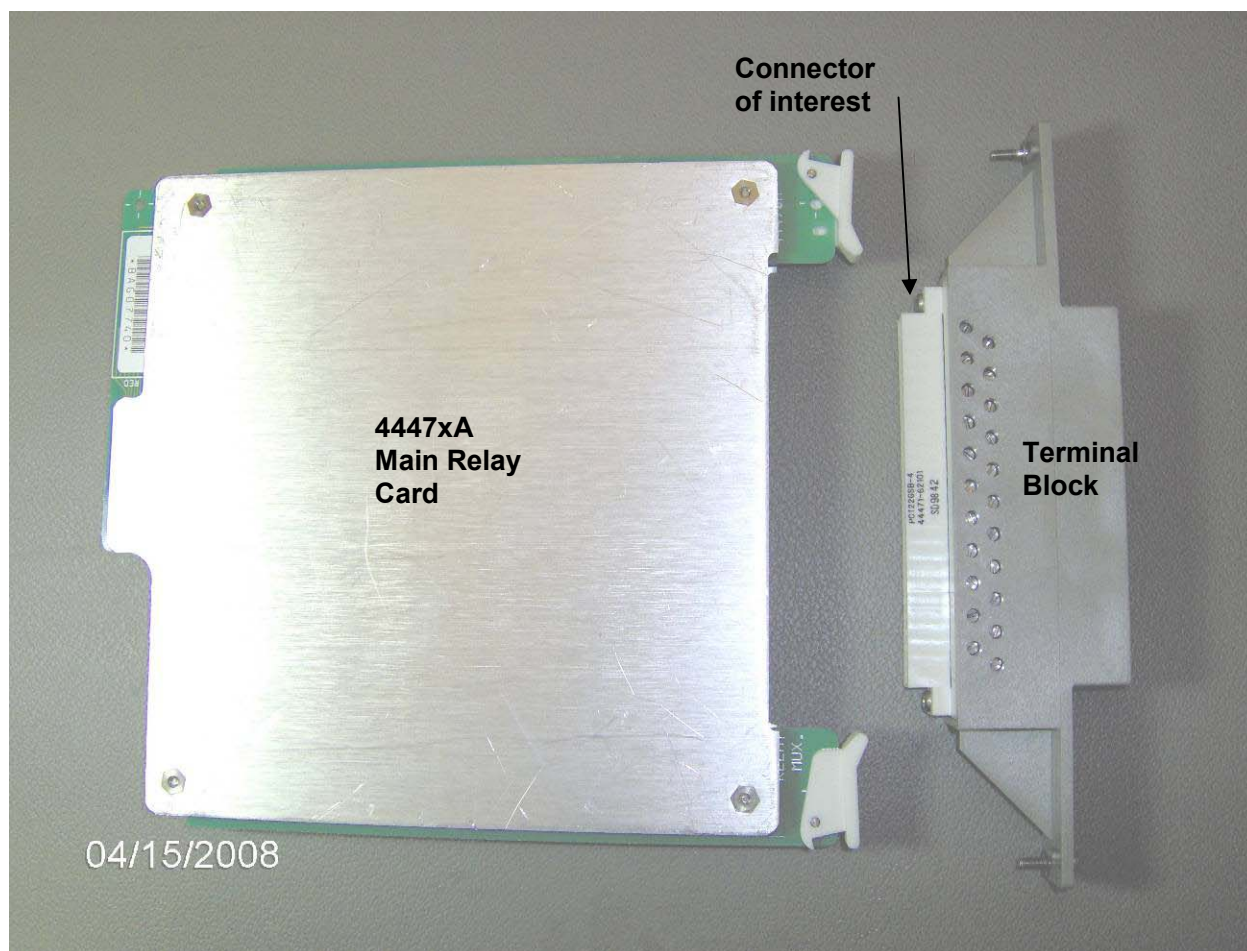
**Figure 1: Main Relay Card and Terminal Block**

The 44470A, 44471A, 44473A, and 44474A contain a main relay card and a removable screw terminal block (see Figure 1). Some of the removable terminal blocks that were shipped between 1-Jan-2008 and 08-April-2008 have a defective connector that results in half of the pins being unconnected.

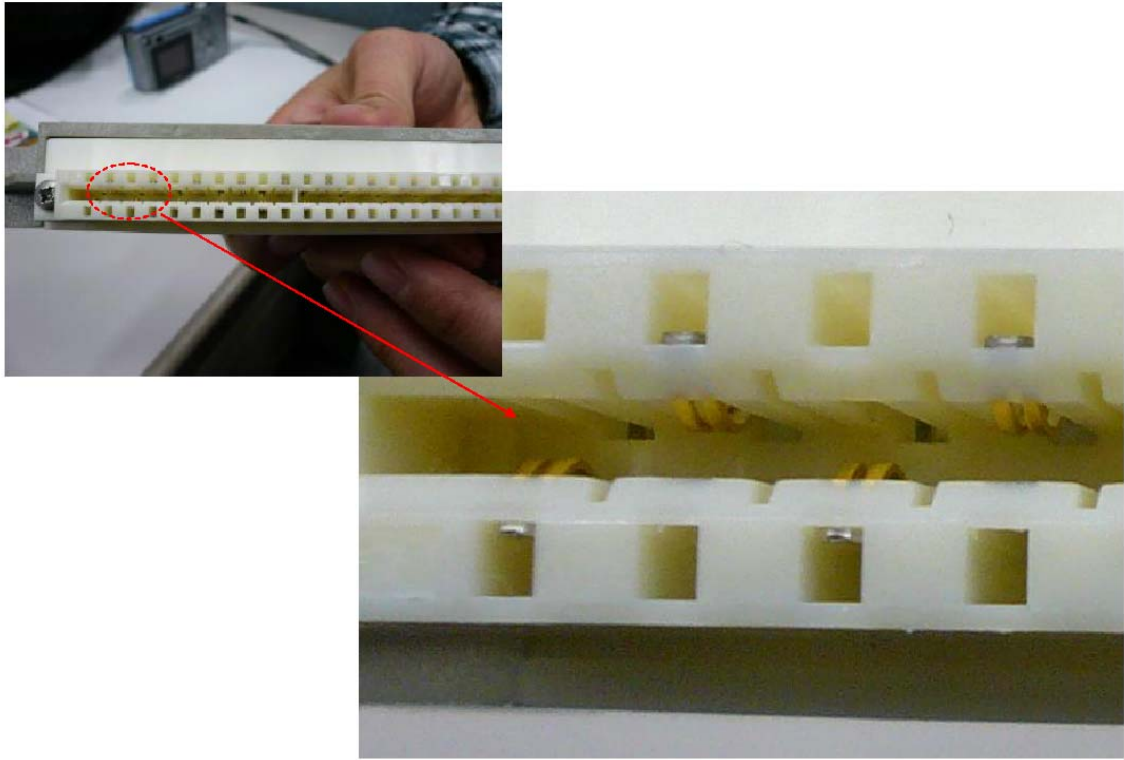
**Figure 2: Good Connector with alternating pins on top and bottom**

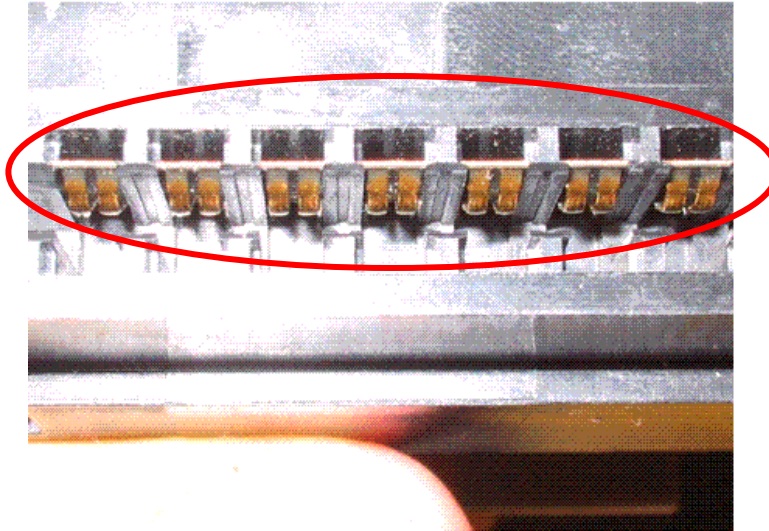
**Figure 3: Defective Connector with all pins on one side**

The procedure to correct the defective connectors is very simple. One must replace the defective connector with a good connector (see connector part numbers list on page 2). The customer may perform this procedure or have an Agilent-qualified person perform this procedure.
