44470A-01A

S E R V I C E N O T E

44470A 10 channel multiplexer module for 3499A/B. Includes a screw terminal block

Defective connectors shipped with 44470A, 44471A, 44473A, 44474A

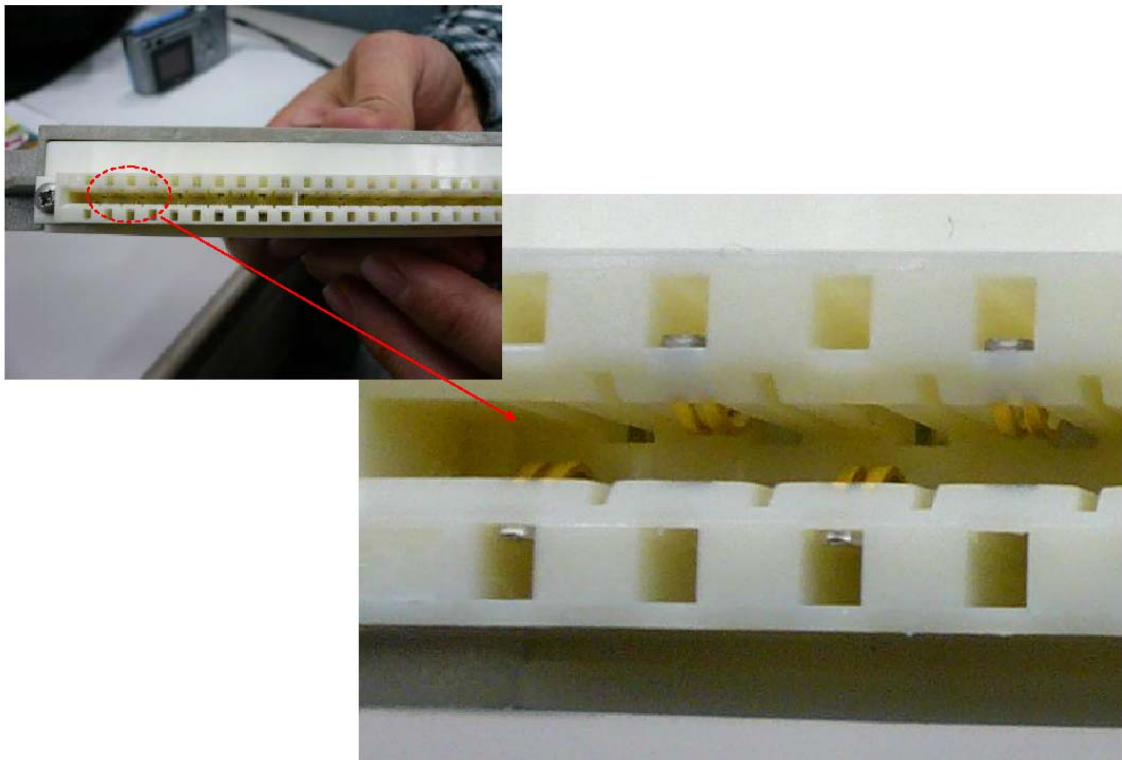
Figure 2: Good Connector with alternating pins on top and bottom

The 44470A, 44471A, 44473A, and 44474A products consist of a main relay plug in module and a removable terminal block (see Figure 1). These are plug in modules for the card cage mainframes 3488A, 3499A, 3499B, and 3499C. The main relay card contains the serial number. The removable terminal module does not contain a serial number. It is possible that over time a terminal block will no longer be used with the same serialized relay card that it was shipped with. A visual inspection of the connector in the removable terminal block is necessary to determine if a defective connector is present. The visual inspection should override the serial number range limits. All white colored connectors are good and have pins that alternate top to bottom (see Figure 2). A black colored connector is bad if it contains all pins on one side of the connector (see Figure 3). A black colored connector is good if it contain pins that alternate top to bottom (not pictured).

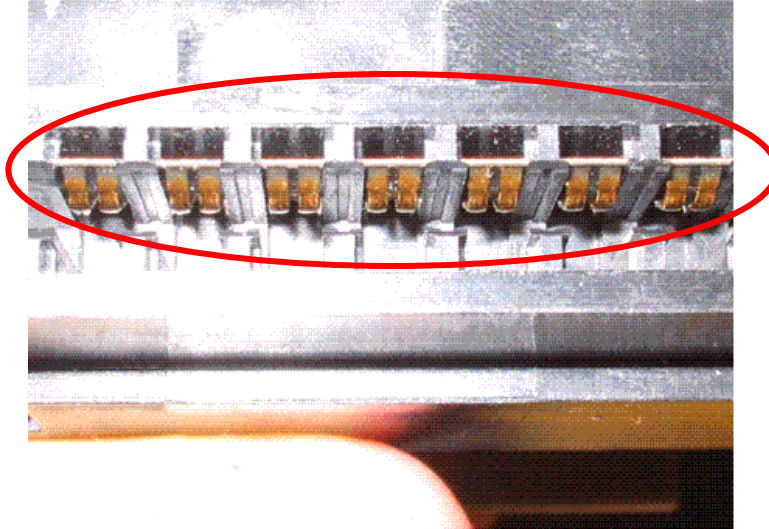
Figure 3: Defective Connector with all pins on one side

The 44470A, 44471A, 44473A, and 44474A contain a main relay card and a removable screw terminal block (see Figure 1). Some of the removable terminal blocks that were shipped between 1-Jan-2008 and 08-April-2008 have a defective connector that results in half of the pins being unconnected.

The procedure to correct the defective connectors is very simple. One must replace the defective connector with a good connector (see connector part numbers list on page 2). The customer may perform this procedure or have an Agilent-qualified person perform this procedure.
