**44471A-01****S E R V I C E N O T E**Supersedes:  
NONE**44470A** 10 channel multiplexer module for 3499A/B. Includes a screw terminal block**44471A** 10-channel General Purpose Relay for 3499A/B. Includes a screw terminal block**44473A** 4x4 Matrix Module for 3499A/B. Includes a screw terminal block**44474A** 16-bit Digital I/O Module for 3499A/B. Includes a screw terminal block**Serial Numbers:**

April 23, 2008

**Defective connectors shipped with 44470A, 44471A, 44473A, 44474A**

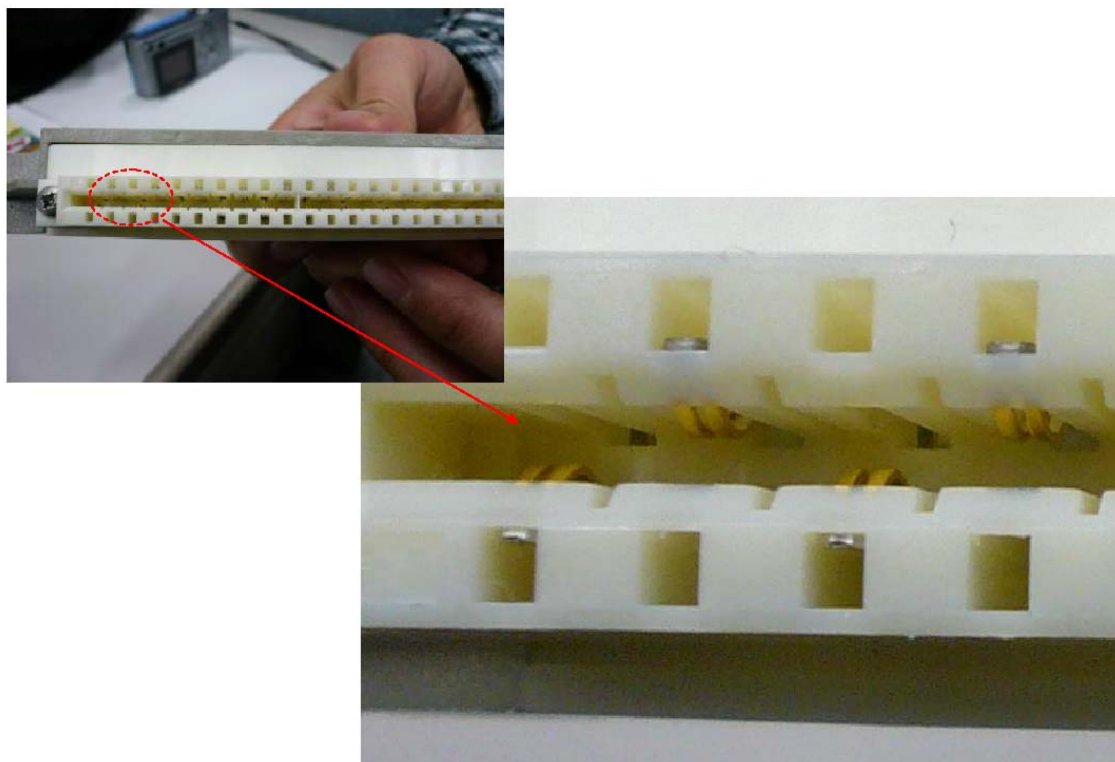
**Figure 2: Good Connector with alternating pins on top and bottom**

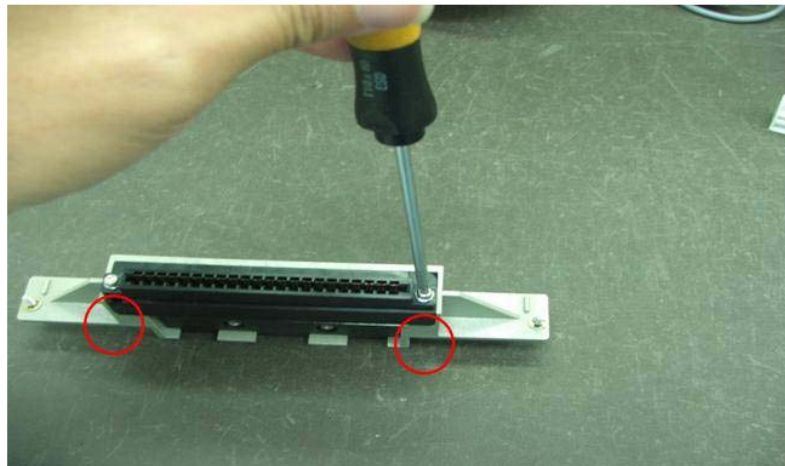
**Figure 4: Removing defective connector from terminal block**

**Connector Replacement Procedure:** After identifying a defective connector, the connector in the terminal block is repaired by removing the two screws that hold the connector to its case. Note the orientation of the connector. This will release the connector from the terminal block and then a good one can replace it. No soldering is necessary. See Figure 4.

1. Use a T10 torx driver to unscrew the 2 screws of the connector.

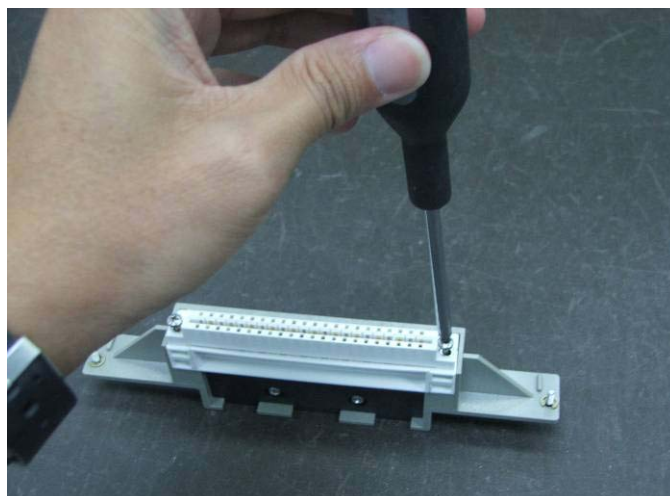
**Figure 5: Good Connector attached to terminal block**

Use the same torx driver to screw on the good connector, using the same orientation at the connector you just removed (see Figure 5).
