**44473A-01****S E R V I C E N O T E**Supersedes:  
NONE**44470A** 10 channel multiplexer module for 3499A/B. Includes a screw terminal block**44471A** 10-channel General Purpose Relay for 3499A/B. Includes a screw terminal block**44473A** 4x4 Matrix Module for 3499A/B. Includes a screw terminal block**44474A** 16-bit Digital I/O Module for 3499A/B. Includes a screw terminal block**Serial Numbers:**

April 23, 2008

**Defective connectors shipped with 44470A, 44471A, 44473A, 44474A**

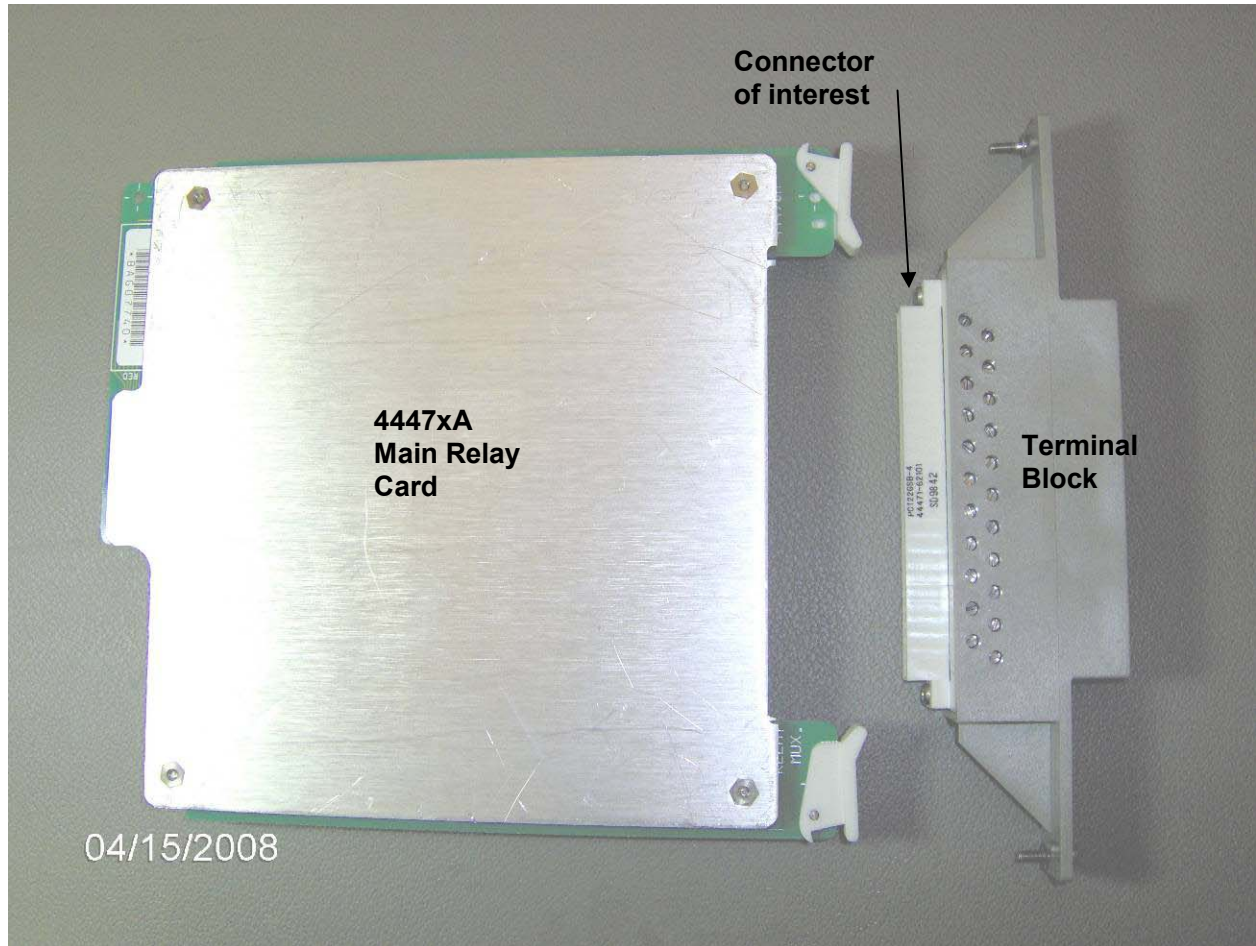
**Figure 1: Main Relay Card and Terminal Block**

The 44470A, 44471A, 44473A, and 44474A contain a main relay card and a removable screw terminal block (see Figure 1). Some of the removable terminal blocks that were shipped between 1-Jan-2008 and 08-April-2008 have a defective connector that results in half of the pins being unconnected.
