**44474A-01****S E R V I C E N O T E**Supersedes:  
NONE**44470A** 10 channel multiplexer module for 3499A/B. Includes a screw terminal block**44471A** 10-channel General Purpose Relay for 3499A/B. Includes a screw terminal block**44473A** 4x4 Matrix Module for 3499A/B. Includes a screw terminal block**44474A** 16-bit Digital I/O Module for 3499A/B. Includes a screw terminal block**Serial Numbers:**

April 23, 2008

**Defective connectors shipped with 44470A, 44471A, 44473A, 44474A**

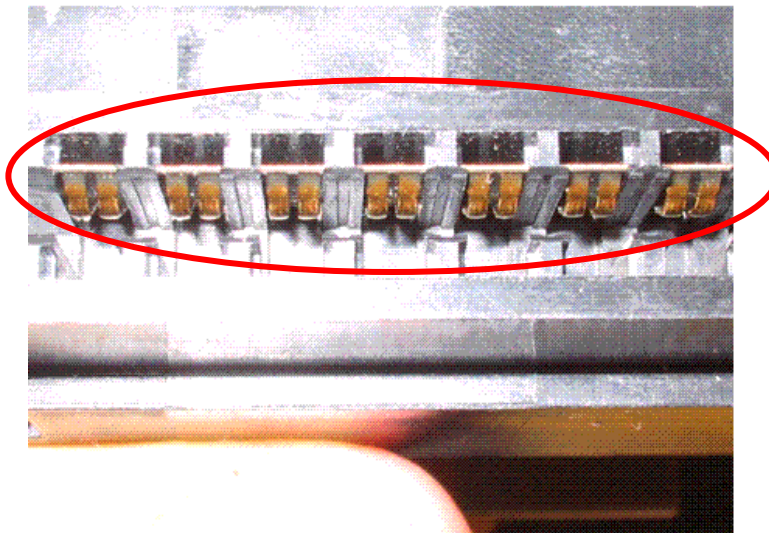
The 44470A, 44471A, 44473A, and 44474A contain a main relay card and a removable screw terminal block (see Figure 1). Some of the removable terminal blocks that were shipped between 1-Jan-2008 and 08-April-2008 have a defective connector that results in half of the pins being unconnected.

**Figure 3: Defective Connector with all pins on one side**

The procedure to correct the defective connectors is very simple. One must replace the defective connector with a good connector (see connector part numbers list on page 2). The customer may perform this procedure or have an Agilent-qualified person perform this procedure.

**Connector Replacement Procedure:** After identifying a defective connector, the connector in the terminal block is repaired by removing the two screws that hold the connector to its case. Note the orientation of the connector. This will release the connector from the terminal block and then a good one can replace it. No soldering is necessary. See Figure 4.

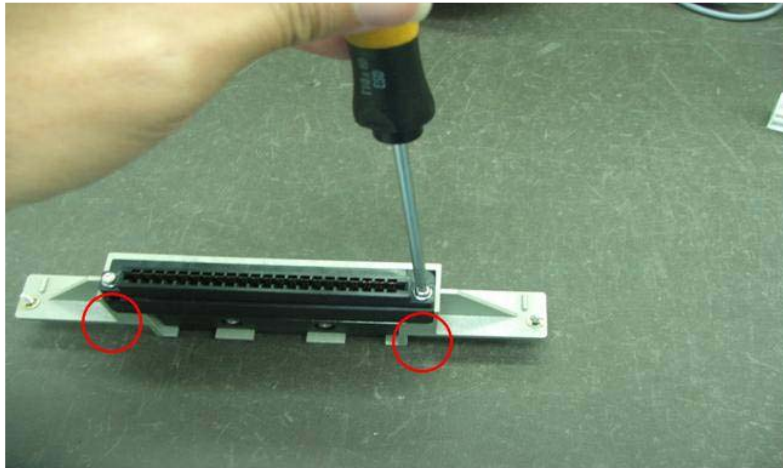
**Figure 4: Removing defective connector from terminal block**

1. Use a T10 torx driver to unscrew the 2 screws of the connector.

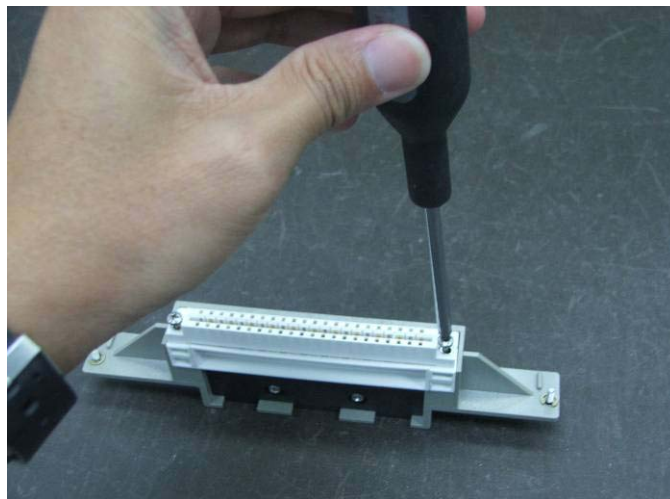
**Figure 5: Good Connector attached to terminal block**

Use the same torx driver to screw on the good connector, using the same orientation at the connector you just removed (see Figure 5).
