S E R V I C E N O T E

HP 4948A In-Service Transmission Impairment Measuring Set

Measurement hang-up with Error Code 2000

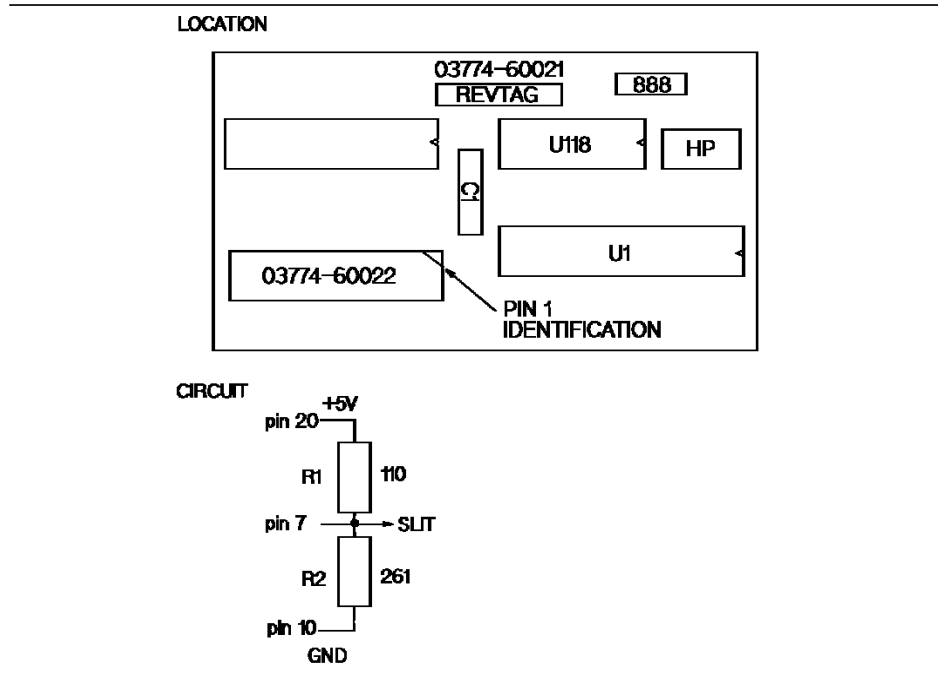
Some recent instruments have shown failures during measurement with a hang-up condition. The Error Code 2000 is displayed and operation can be recovered by re-powering the instrument.

Reflections in clock distribution signal to Condition Multiplexer circuit of the Signal Processor Clock Signal (SLIT) can cause this problem. The signal has been improved by the addition of a termination network.

Add termination network part number 03774-60022 to the A9 piggy-back assembly 03774-60021. Note the network plugs into a spare 20 pin socket located on the piggy-back assembly. Orientation is indicated by chamfer at pin 1. See Figure below.

After replacement check the instrument passes power-on checks. This is indicated by the INDEX page being displayed after power-on test.
