S E R V I C E N O T E

4957PC Protocol Analyzer

Auto-Configuration Anomaly

DATE: 22 November 1991

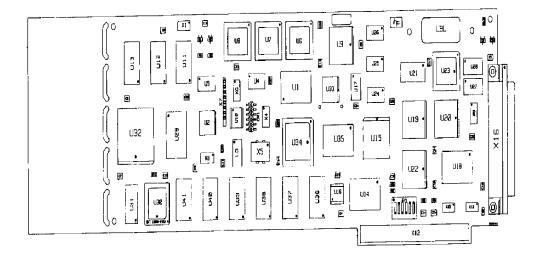
Fig. 1

4957PC Card 04957-66503/4/5/6

Referencing Figure 1, locate the three ROMS in the upper center of the PC board. Remove the three ROMS from their sockets, noting the orientation of the ROM in the socket. Place the new ROMS in the sockets in the following matter:

Ref. Desg.	Old Part No.	New Part No.	
U6	04957-19009	04957-19025	(Standard)
	04957-19014	04957-19027	(Option 001)
U7	04957-19010	04957-19024	
U8	04957-1911	04957-19026
