S E R V I C E N O T E

HP 4991A LanProbe

Modification to fix "Node Movement, or Node Hopping," and Network performance (throughput) problem.

Page 2 SERVICE NOTE 4991A-13

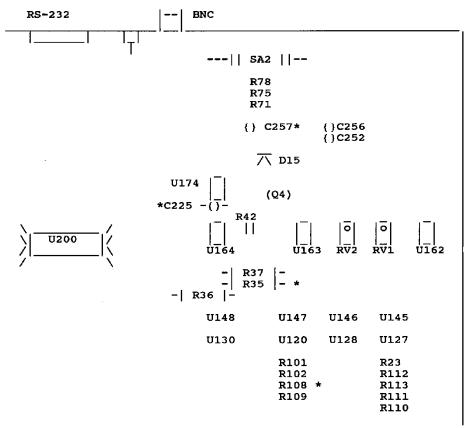
^{**} Board numbers 04991-69511/69511 could be rev. D or E. The board must match the pictorial diagram below before modification. If it does not match-DO NOT MODIFY.

Revision E boards have U200 heat sink. Rev. D boards DO NOT have the heat sink, it has a CHS1209 device.

- 1. Locate C225, remove and install new C225 0160-7175 4700pf.
- 2. Locate C257, remove and install new C257 0160-7172 1000pf.
- 3. Locate R108 (10Kohm) and replace with new 0757-0290 6.19Kohms.
- 4. Locate R35 and remove.
- 5. Locate U164 and cut pin 7 at IC body (ensure no continuity).
- 6. Affix label 04991-84337 "04991-66510" if working on a 04991-66510 board, or use label 04991-84338 "04991-66519" on 04991-66519 board. Note that the new date code is A-3149-38. Remove the old label before applying the new one.
