S E R V I C E N O T E

HP 4992A NodeLocator

Modification to fix "Node Movement" or "Node Hopping," and Network performance (throughput) problem.

DATE: 07 January 1992

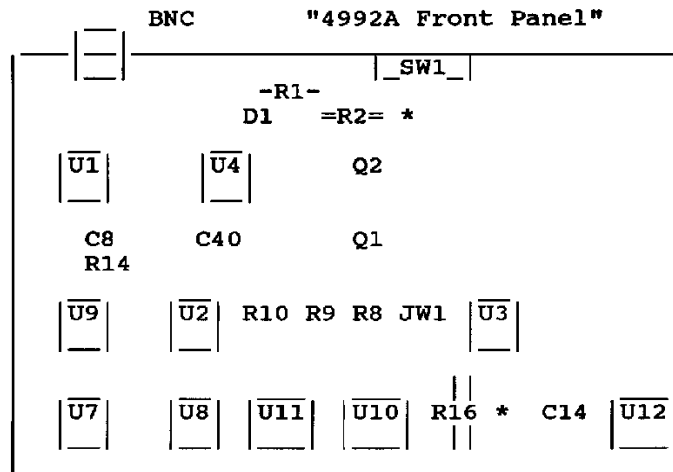
Pictorial: 4992A R2 and R16 Location

The HP4991A LanProbe node location is dependent upon receiving a well defined echo pulse from the HP4992A NodeLocator. This pulse has worked well in many applications until recently when the echo pulse began to create network performance problems or node location problems on some customer's networks.

1. Node "Hopping/Movement" - This is seen as node distance measurements moving when the node has not moved.
2. Throughput performance - There is a noticeable delay (increased time delay) between transmitted data and/or refreshing screen (graphic/text) between nodes on a customer's network.

1. Locate and remove R2. Replace R2 with 0757-0395 56.2 ohm.
2. Locate and remove R16. Replace R16 with 0698-3153 3.83 K ohm.
3. Remove old board label and replace with new board label (new label has new date code).
