# S E R V I C E N O T E

## 4996A LanProbe II PV

# **Repair of the Serial Port Controller**

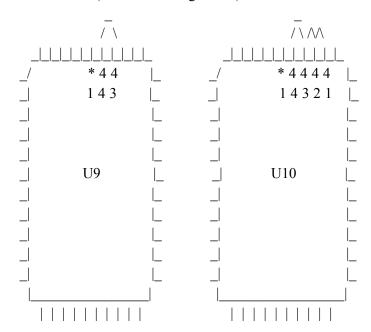
It was discovered that the serial controller chip on this product has floating inputs. The result of these floating inputs may cause erroneous interrupts to the processor chip. This design error was discovered when NTD received a batch of controller chips that were more sensitive to the input signals. While these inputs float they may randomly cross the threshold and cause an interrupt request to the processor. This problem may slow the response of the LanProbe or worst case will cause the LanProbe to warm start randomly.

- 1.Remove the front bezel and top cover to expose the main PCBA.
- 2. Locate U9 and U10 on the main PCBA 04996-66501. Add a jumper wire to short pin 44 VCC to 43 on U9. Add a jumper wire to short pin 44 VCC to pins 43, 42, and 41 on U10. (NOTE: drawing below).
