53131A-07

# S E R V I C E N O T E

## 53131A 225 MHz Counter

Serial Numbers: MY47000000 to MY47003808  
SG47000000 to SG47000255

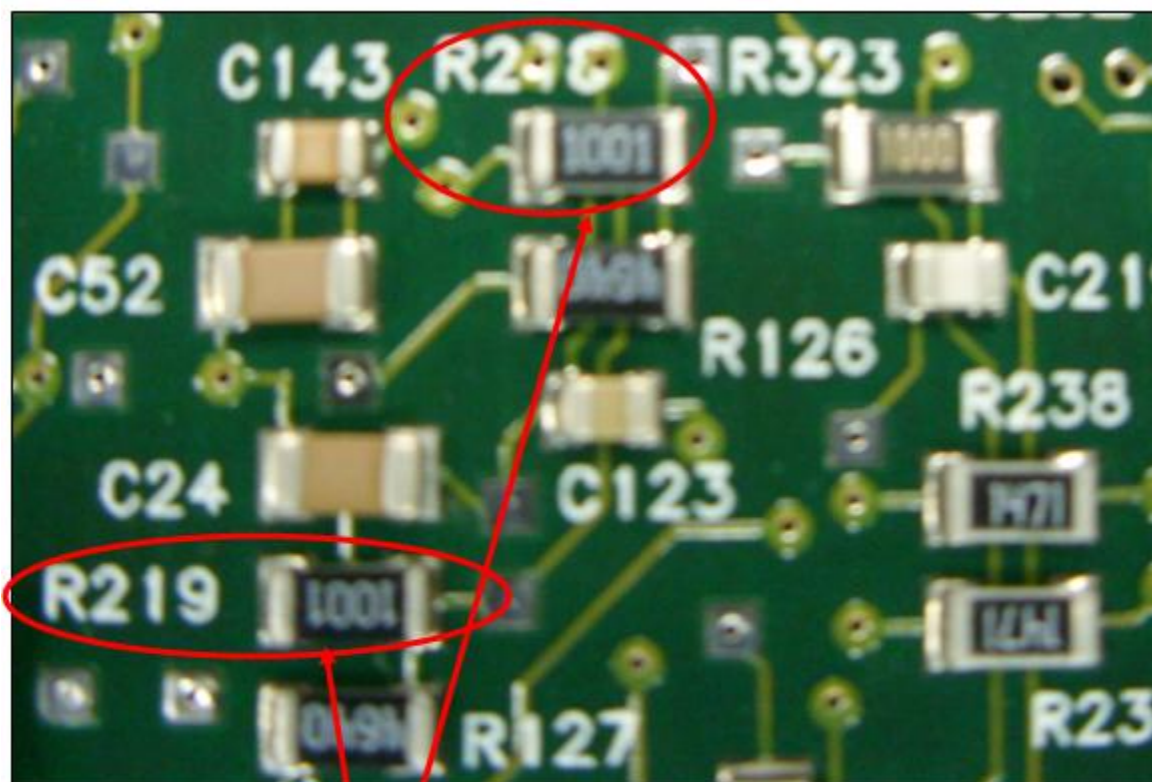
Incorrect triggering can occur if both channels have been configured for a measurement since the last power cycle or if large signals ( $> 10$  Vpp) are used. The counter may use the trigger from one channel to initiate a measurement on the other channel.

Replace resistor 0699-1318 at reference designators R219 and R218 with 0699-1377 (2.37 KOhm).
