53132A-05

<u>SERVICE NOTE</u>

53132A - 225 MHz Counter

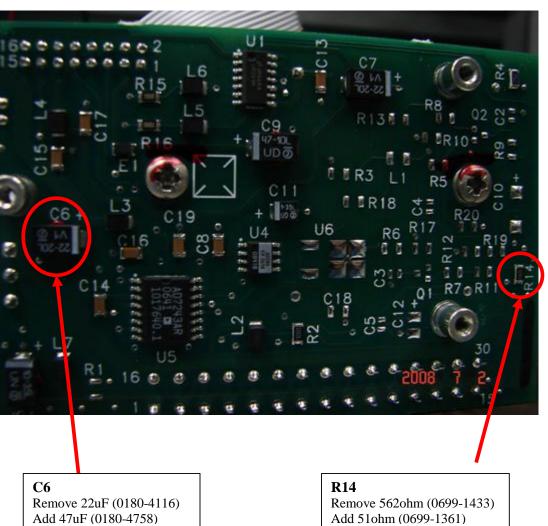
A manufacturing change to the oscillator, part numbers 10811-60160 (option 010) and 10811-60260 (option 012), causes a failure at power-on self test if the newer oscillators are replaced on to time base (A6) boards that have an EDC code less than 4829 on the board.

Add 51ohm (0699-1361)

- Remove R14, 562ohm resistor and replace with 51ohm resistor (0699-1361).
- Remove C6, 22uF capacitor and replace with 47uF capacitor (0180-4758).
