**53132A-06**

**S E R V I C E N O T E**

**53132A 225 MHz Counter**

**Bumper feet on Power Supply and beneath Motherboard can deteriorate/break down over time**

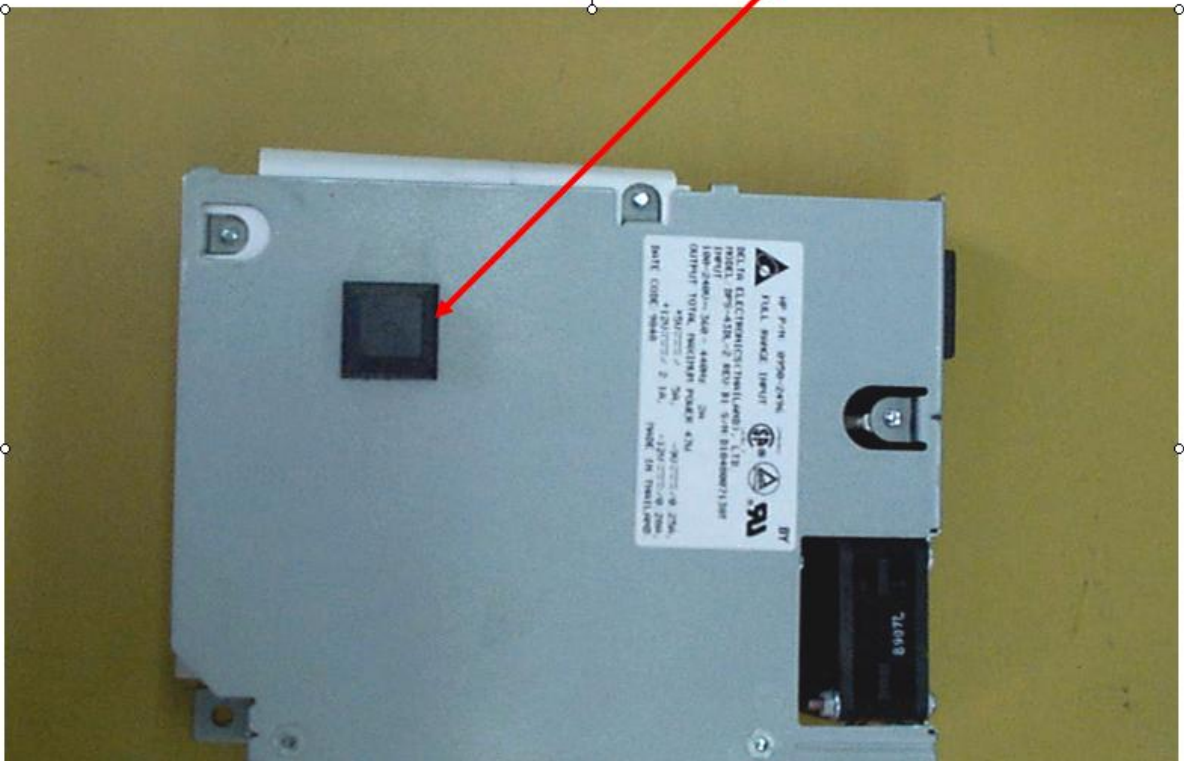
Bumper 0403-0424

There are two bumper feet used on the counter – one on the power supply sheet metal, and another beneath the motherboard.

On older units (> 4 years old), we have seen some bumpers that have melted, or are now sticky and soft. The manufacturer of the bumpers indicates there can be two causes of bumper degradation:

On units older than 4 years or so, or on units known to have come from harsh (chemically) environments, open the unit and inspect the bumpers. If during examination, either bumper is easily compressed when squeezing (soft), is sticky to the touch, or if it shows signs of melting, then replace BOTH bumpers.
