53181A-04

S E R V I C E N O T E

53181A - 225 MHz Counter

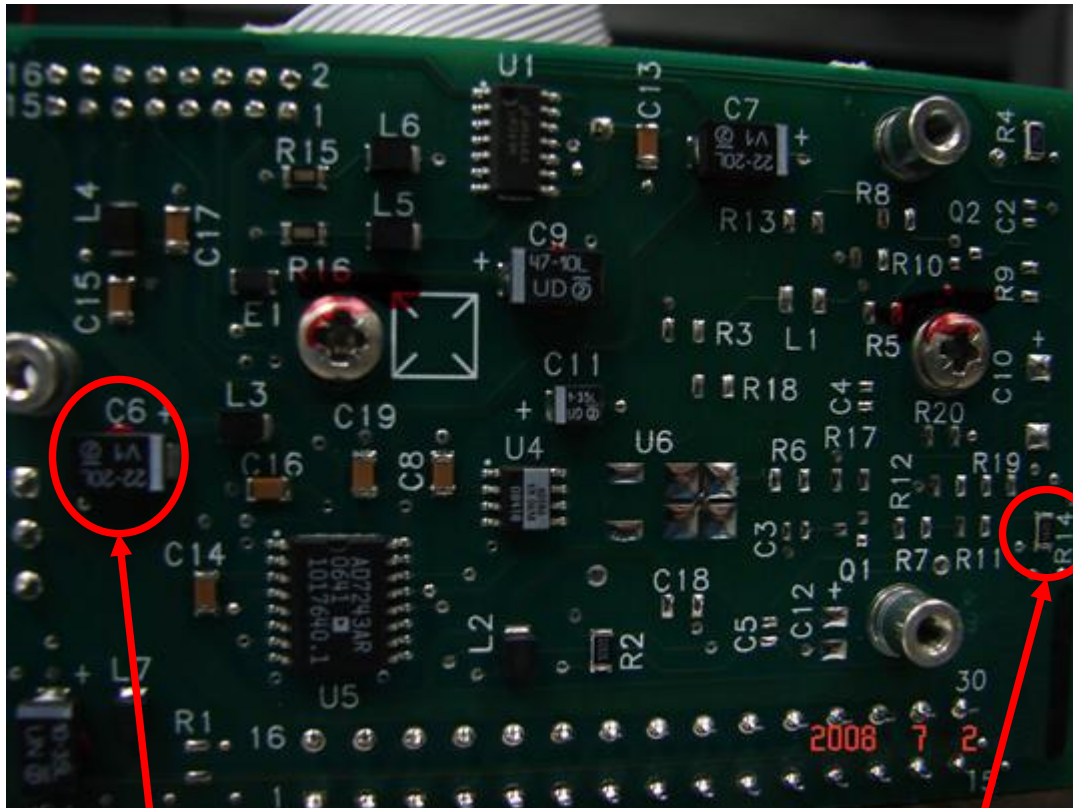
A manufacturing change to the oscillator, part numbers 10811-60160 (option 010) and 10811-60260 (option 012), causes a failure at power-on self test if the newer oscillators are replaced on to time base (A6) boards that have an EDC code less than 4829 on the board.

Optional repair (see picture):

1. Remove R14, 562ohm resistor and replace with 51ohm resistor (0699-1361).
2. Remove C6, 22uF capacitor and replace with 47uF capacitor (0180-4758).

C6
Remove 22uF (0180-4116)
Add 47uF (0180-4758)

R14
Remove 562ohm (0699-1433)
Add 51ohm (0699-1361)
