HP MODEL 5345A ELECTRONIC COUNTER

Serial Prefix 1920A and Below

MECHANICAL INTERCONNECTION WITH PLUG-INS

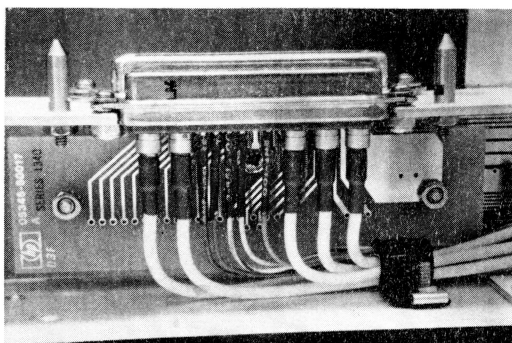
A few 5345A mainframes have exhibited a reluctance to easily accept mechanical interconnection with plug-ins. On inspection of these units, it was determined that the coax cables within W5J1 plug-in connector are tied in such a way as to force the rf connectors off center. This prevents them from properly mating with their plug-in counterparts.

Proper Cable Routing

If this condition exists in a field unit, use the following technique to properly align the rf cables: within the 5345A plug-in compartment, remove the four screws holding the connector cover. Remove the cover from the connectors to expose the connector wiring. The wiring from the top connector (W5J1) runs through a clamp which is attached to the rear panel. Loosen this clamp and move the wiring so it is perpendicular to the connector (i.e., so it goes straight back from the connector and is not immediately pulled to one side). Tighten the clamp connection and replace the cover.
