5DX-83A-S <u>S E R V I C E N O T E</u>

5DX Series I, II, 2L, 3 and Series 5000 Systems

POSSIBLE LASER EMISSION HAZARD

5DX Systems with two lasers installed will not function properly if the front laser to rear laser interlock jumper cable (E7200-61706) is mis-wired. The jumper wire being mis-wired enables the lasers to stay on all the time even if an access panel interlock is opened.

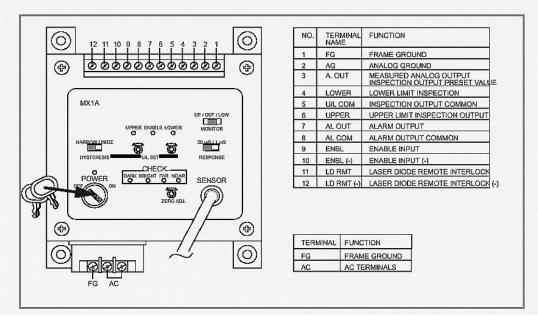
Figure 1

- 14) If either Laser Spot remained on, the laser did not turn off. This means that the E7200-61706 cable is mis-wired.
- 15) Turn off the Laser Power units by turning both keys to the off position.
- 16) Reverse the LD RMT(-) and LD RMT wires on one end of the E7200-61706 cable. See Figure 1.
- 17) Turn on the Laser Power units by turning both keys to the on position.
- 18) Continue with step 1.
- 19) Close the 5DX access panel.
- 20) Run Automatic Startup.
- 21) Unload C & A Panel.

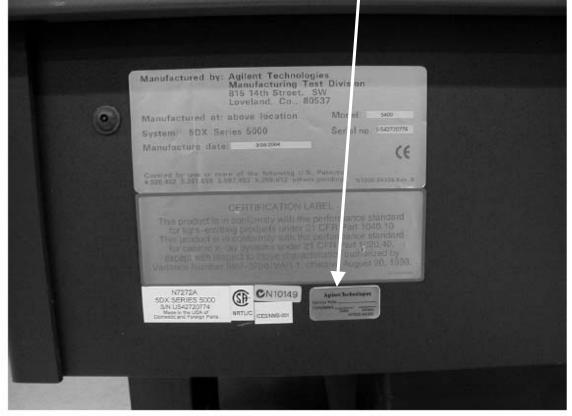
Figure 2: N7200-84366 Service Note label installed at lower right of label area.

- 22) Upon completion fill out and install the Service Note label (Part Number N7200-84366) to the 5DX label area.
- Note the N7200-84366 label located to the lower right of the existing labels in the photo below.
