S E R V I C E N O T E

6032A Autoranging DC Power Supply

Serial Numbers: 3102A07001 / 3138A07740

Modification using RTV to prevent W8 Ribbon Cable disconnect.

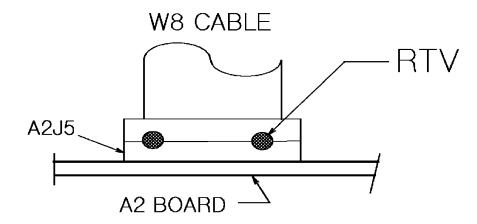
Figure 1

The W8 ribbon cable connecting the A1 main board assembly to the A2 Control board assembly may vibrate loose during transportation. This only involves units with serial numbers inclusive of those listed above.

Reconnect the W8 ribbon cable. Use RTV to secure the W8 connector to the J5 mating connector on the A2 assembly. Put a 8 mm (0.313 in) size spot bridging the W8 / J5 connectors. Bridge the connectors with an RTV spot at each end as shown in figure 1.
