6571A-09

<u>SERVICE NOTE</u>

6571A DC POWER SUPPLY, 0-8 V, 0-220 A, 1760 W. MANUALLY CONTROLLED.

The **AC INPUT SAFETY COVER** has a strain relief used to secure the AC line cord that may become loose.

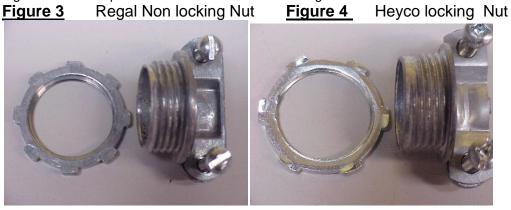
<u>Figure 5</u> <u>Figure 6</u>

Figures 4 & 6 is representative of a nut with locking ribs.

The entire AC **INPUT SAFETY COVER** P/N 5040-1676 should be replaced.
