6574A-07A

S E R V I C E N O T E

6574A DC POWER SUPPLY MANUALLY CONTROLLED

**Serial Numbers: US36340525/US36340725 & MY41000101/MY41000350 &
SG41000101/SG41000280**

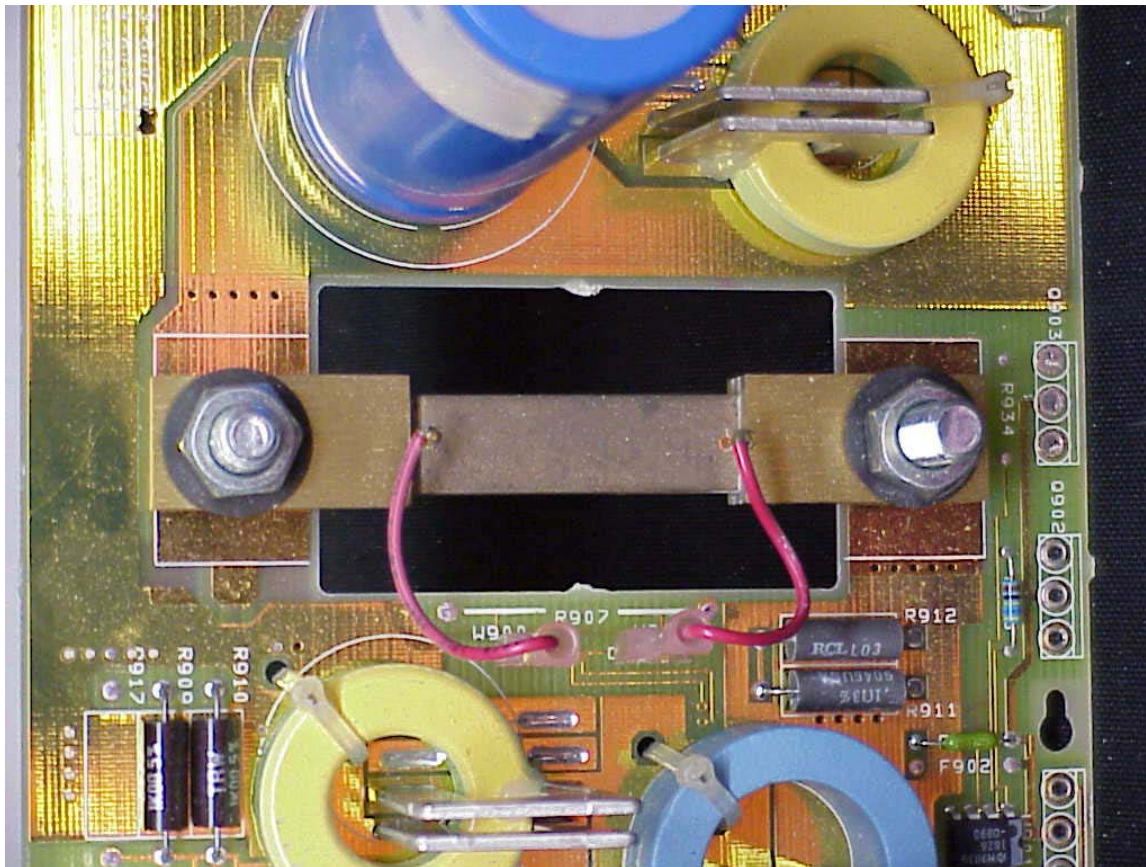
The Current Shunt (Circuit Reference “R907”) may have intermittent sense wires, which may cause Instability of Current regulation, Current read back and Current programming.

When the push-on connectors become intermittent the output current will become unstable. Loose push-on connectors can cause the output current to change dramatically. The current can change from any set current, and may go to the maximum rated output current of the instrument.

This picture shows how the Shunt R907 is connected using the term-crimp connectors.

The Shunt R907 is connected to "W900" & "W901"

Cut the terminal-crimp connectors off of both wires and discard the connectors. Make this cut as close to the terminal-crimp connector as possible. The required strip length should be 5mm. This strip length will be used to prevent the wire length being too long and shorting to the instrument chassis. If replacement of this wire is required any color (22 AWG, 300V 105C) wire type can be used.

This modification can be done from the top of the board. Carefully strip and solder the wires, and avoid burning the wire insulation and the printed circuit board.
