6575A-10

SERVICE NOTE

6575A DC POWER SUPPLY, 0-120V, 0-18 A, 2100 W. MANUALLY CONTROLLED.

The **AC INPUT SAFETY COVER** has a strain relief used to secure the AC line cord that may become loose.

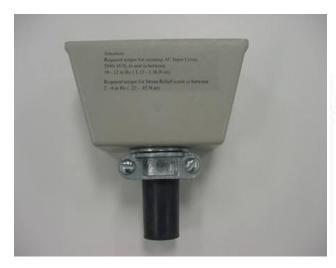
The individual parts shown in **Figure 8** are not available from Agilent parts "SPO" (Support Parts Organization). It is not cost affective to repair the AC **INPUT SAFETY COVER**, a special tool is required to tighten the nut shown in Figure 2.

The information below is what is printed on the label shown in Figure 8

Required torque for securing AC Input Cover, 5040-1676, to unit is between 10 – 12 in lbs (1.13 – 1.26 N.m).

Required torque for Strain Relief screw is between tightened using 2inlb torque.

ONLY replace the AC Safety Cover P/N 5040-1676 if the label shown in Figure87 does not appear on the Safety cover or if the Cover is defective due to described failure, the Safety cover should be replaced at **NO** charge to the customer.
