66000A-07

S E R V I C E N O T E

66000A MODULAR POWER SYSTEM MAINFRAME - 8 SLOTS, GP-IB

The **AC INPUT SAFETY COVER** has a strain relief used to secure the AC line cord that may become loose.

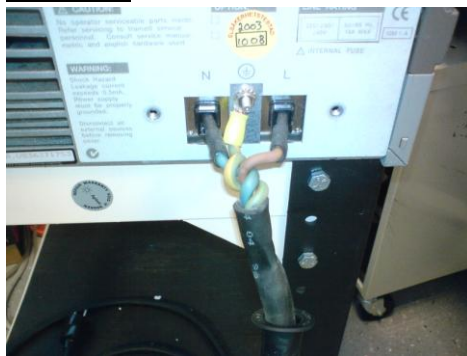
Figure 1 is an example of what happens when the strain relief will become loose, the line cord becomes twisted. When a heavy line cord is used the strain relief becomes loose very easily, and the line cord cable can rotate freely.

The entire AC **INPUT SAFETY COVER** P/N 5040-1676 should be replaced.

The line cord should also be securely fastened at a point 6 to 12 inches away from **INPUT SAFETY COVER** as shown in [Figure 7](#). When this type of strain relief is used the electrical code requires the cord/cable being held by the strain relief be secured. Doing this eliminates the cable or cord from being twisted as shown in figure 1.

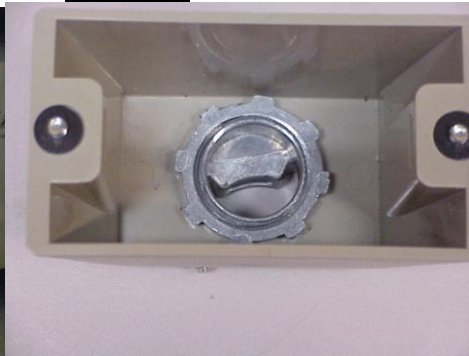
Figure 2 shows the inside of the AC Safety Cover housing the incorrect hardware is shown. It will be very difficult to tighten the strain relief. AMC (Asian Manufacturing Center) uses a special tool to tighten the locking nut. When the incorrect nut is used or a locking Nut is put on incorrectly the strain relief will become loose as described above.

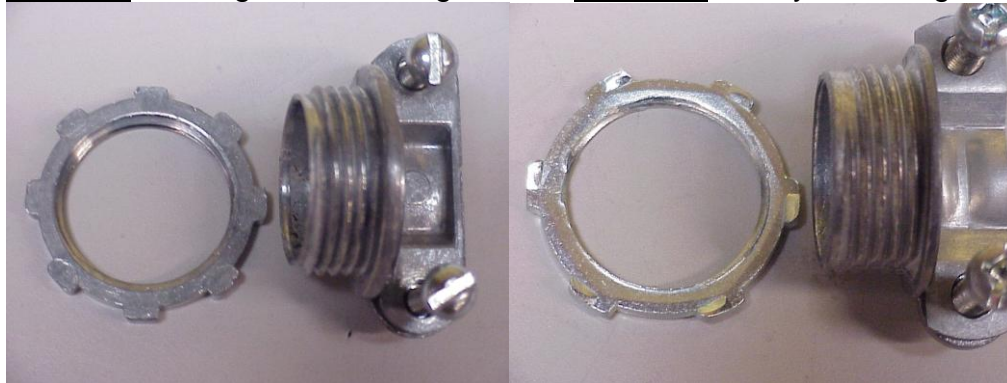
Figure 3 Regal Non locking Nut

Figures 3 & 5 is representative of a not without locking ribs.

Figures 4 & 6 is representative of a nut with locking ribs.

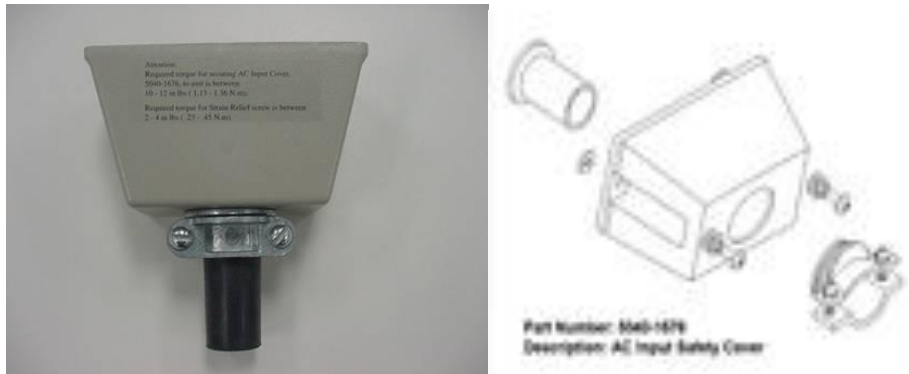
The individual parts shown in **Figure 8** are not available from Agilent parts “SPO” (Support Parts Organization). It is not cost affective to repair the AC **INPUT SAFETY COVER**, a special tool is required to tighten the nut shown in Figure 2.

The information below is what is printed on the label shown in **Figure 8**

Required torque for securing AC Input Cover,
5040-1676, to unit is between
10 – 12 in lbs (1.13 – 1.26 N.m).

Required torque for Strain Relief screw is between
tightened using 2inlb torque.

ONLY replace the AC Safety Cover P/N 5040-1676 if the label shown in Figure 8 does not appear on the Safety cover or if the Cover is defective due to described failure, the Safety cover should be replaced at **NO** charge to the customer.
