66106A-08A

SERVICE NOTE

66106A DC Power Supply

The instrument will not communicate or will not complete self test. Parts Required:

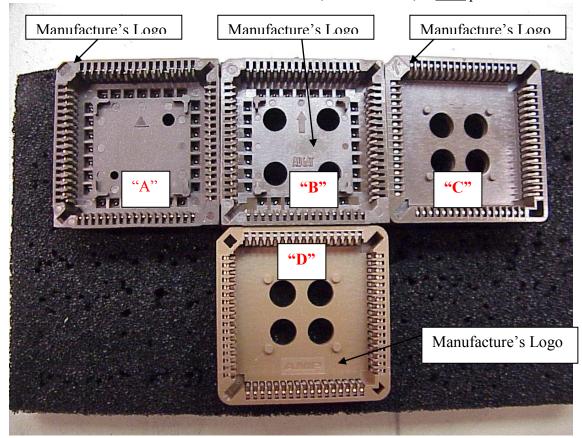
Figure 2

This figure should be used to identify **GOOD** sockets and a potential defective socket. The **16-Bit MCU 16 MHZ 68PLCC CMOS IC** (P/N 1821-1479) is <u>NOT</u> pictured.

Socket "A" is a sample of a GOOD AMP socket.

Socket "B" is a sample of a GOOD Tyco/Augit socket.

Socket "C" is a sample of a GOOD FCI socket.

Socket "D" is a sample of a DEFECTIVE Tyco socket.

The sockets above labeled "A","B" or "C are good and should NOT be replaced.

The socket above labeled "D" is considered defective should replaced.

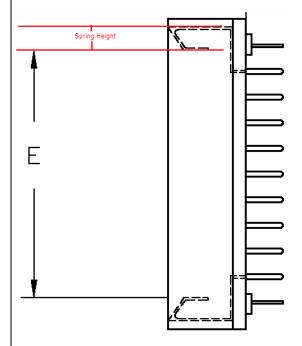
The condition of the recessed beams has been corrected by a design enhancement implemented in production. This design enhancement increased the spring height dimension by 0.04mm and decreased the spring height tolerance by 40%. The spring height dimension is shown in the drawing below.

This design enhancement is intended to position the contact beams closer to the middle of the socket and increase the normal force exerted on the contacts of the chips mated to the socket.
