6611C-07A

S E R V I C E N O T E

Agilent 6611C DC Power Supply

On faster computers, when programming over GPIB, a random error will occur.

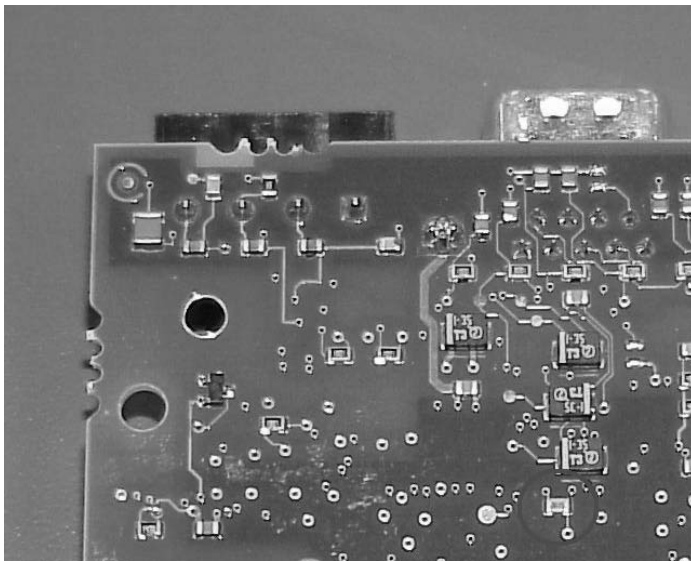
When programming a unit over GPIB, a random error -113 (“Undefined header”) will appear on the unit. This error can be read back via the front panel or over the GPIB bus.

Change resistor R1246 (see picture for location) from 511 Ohms to 100 Ohms (part number 0699-3058). This requires un-soldering and soldering a surface mount component and can be very difficult. This does not require re-calibration.
