66309D-07A

Modification Recommended Service Note

66309D - MOBILE COMMUNICATION DC SOURCE, DUAL-OUTPUT 15V/3A, 12V/1.5A

Serial Numbers: MY43005870 – MY43007235, MY52000625 – MY52000692, SG43005870 – SG43007235

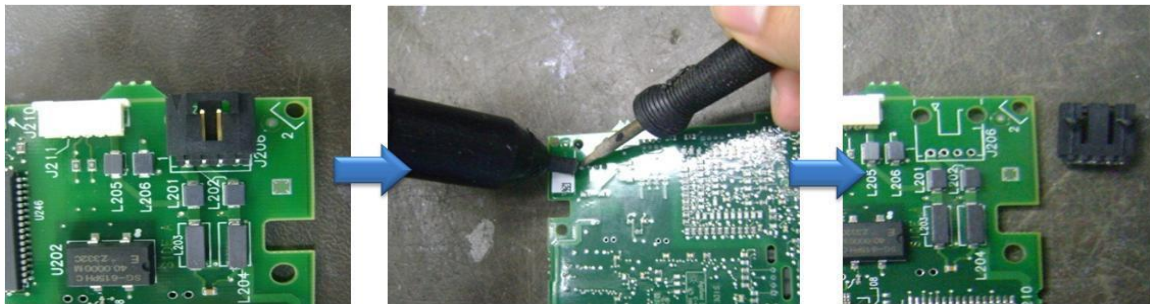
Poor crimping of the connectors on a bias cable can cause intermittent communication issues.

A 5 V bias is required by the A2 Interface PCA. There is a cable with a connector that plugs into circuit reference J206 on the A2 PCA that brings that voltage in. The connector on this cable is the issue.

1. Remove the connector at reference J206 (Keysight part number 1252-3695) from the PCA. All 4 pins from the connector must be de-soldered. The photo below illustrates the process:
