66319D-521-01

S E R V I C E N O T E

66319D with Option #521

Reliability Improvement of Instrument

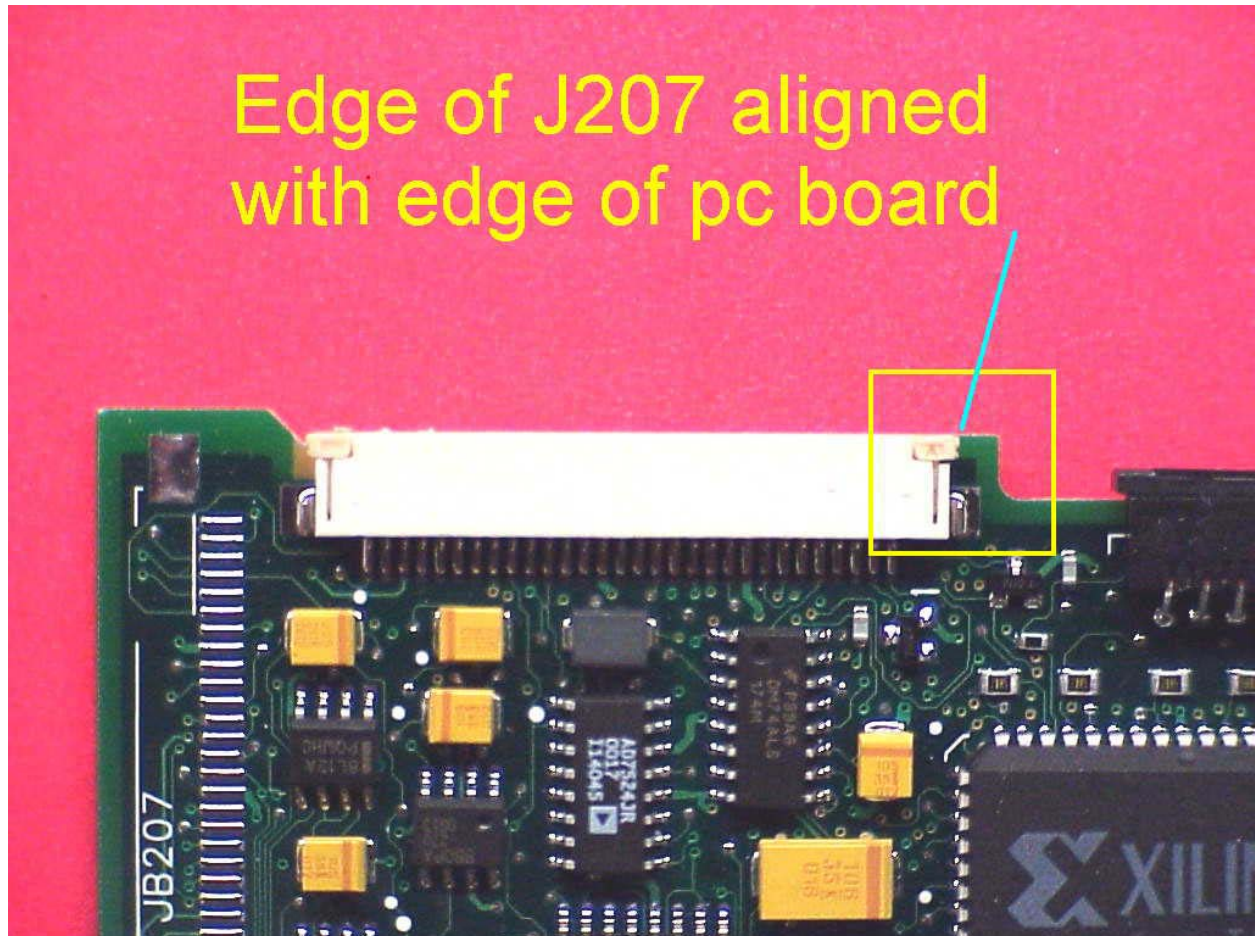
CORRECT J207 PLACEMENT – alignment to within $< 0.3\text{mm}$

Picture shows connector aligned to edge of SMT board to within $< 0.1\text{mm}$
