**66321B-05**

# S E R V I C E N O T E

66321B

## Reliability Improvement of Instrument

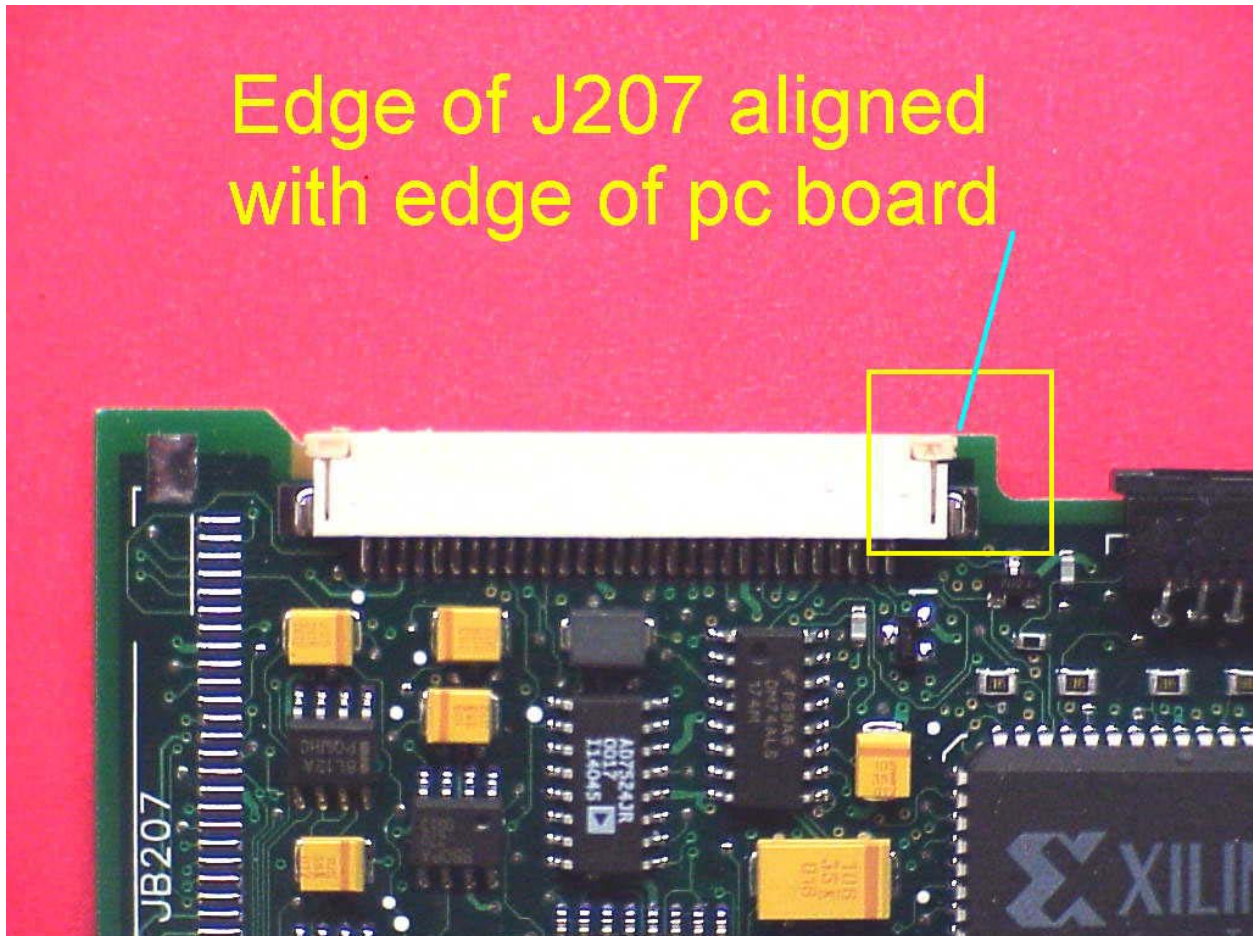
**CORRECT J207 PLACEMENT** – alignment to within  $< 0.3\text{mm}$

Picture shows connector aligned to edge of SMT board to within  $< 0.1\text{mm}$
