### 66321B-08 ERVICE S ΝΟΤΕ

# 66321B - MOBILE COMMUNICATION DC SOURCE, **15V/3A WITH BATTERY EMULATION. GPIB**

Serial Numbers: MY43003160 – MY43003330 SG43003160 – SG43003330

Power-On Self test Errors, Auto reboot, Blank display. No output Communication errors. No communication when using the GPIB Interface.

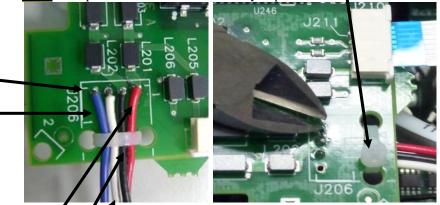
Note the sequence of the cable wires is very important!

The **Red** wire is soldered in the main control board (reference E320) and should be soldered into pin #1 or the square pair of "J206" on the "A2" interface assembly.

The **Black** wire is soldered in the main control board (reference E324) wire should be soldered into pin #2 of "J206" on the "A2" interface assembly.

The White wire is soldered in the main control board (reference E321) should be soldered into pin #3 of "J206" on the "A2" interface assembly.

The **Blue** wire is required for the models shown below **ONLY.** This **Blue** wire comes from the connector on the battery emulation board P/N 5064-0131 circuit reference J001 Pin 12, the **Blue** should be soldered into pin # 4 of "J206" for the models listed below only. All other **66300X Mobile Comm DC Sources** only require 3 wires.
