6634B-08

S E R V I C E N O T E

Agilent 6634B DC Power Supply

On faster computers, when programming over GPIB, a random error will occur.

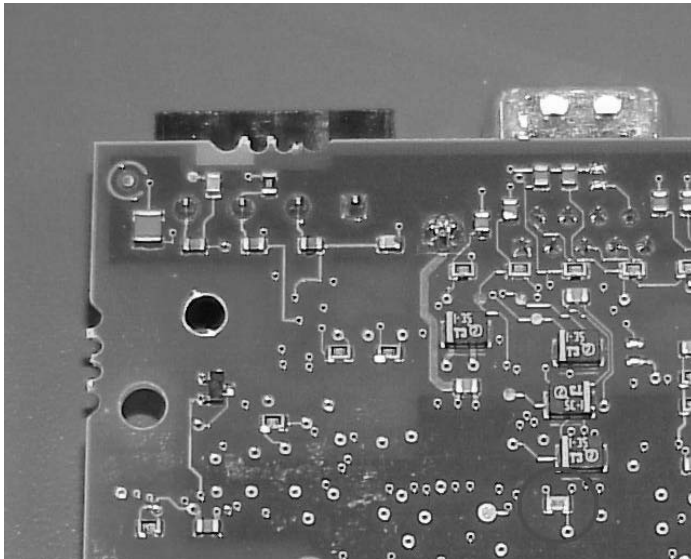
When programming a unit over GPIB, a random error -113 (“Undefined header”) will appear on the unit. This error can be read back via the front panel or over the GPIB bus.

Change resistor R1246 (see picture for location) from 511 Ohms to 100 Ohms (part number 0699-3058). This requires un-soldering and soldering a surface mount component and can be very difficult. This does not require re-calibration.
