6671A-11

S E R V I C E N O T E

**6671A DC POWER SUPPLY, 0-8 V, 0-220 A, 1760 W.
GBIB CONTROLLED.**

The **AC INPUT SAFETY COVER** has a strain relief used to secure the AC line cord that may become loose.

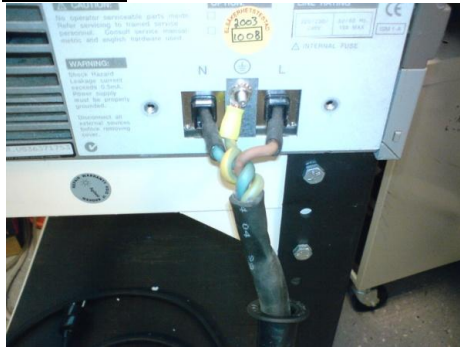
When the incorrect nut is used or a locking Nut is put on incorrectly the strain relief will become loose.

Figure 1 is an example of what happens when the strain relief becomes loose, the line cord becomes twisted. When a heavy line cord is used the strain relief becomes loose very easily, and the line cord cable can rotate freely.

The entire **AC INPUT SAFETY COVER** P/N 5040-1676 should be replaced.

The line cord should be securely fastened at a point 6 to 12 inches away from **INPUT SAFETY COVER** as shown in **Figure 7**. When this type of strain relief is used the electrical code requires the cord/cable being held by the strain relief be secured. Doing this eliminates the cord/cable from being twisted as shown in figure 1.

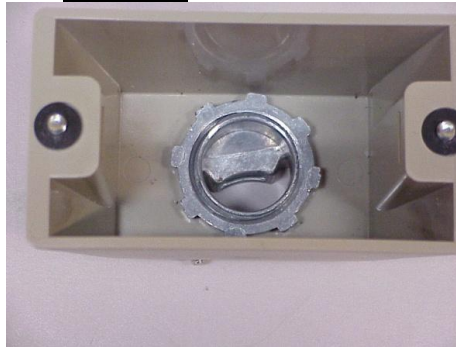
Figure 2 shows the inside of the AC Safety Cover housing the incorrect hardware is shown. It will be very difficult to tighten the strain relief. AMC (Asian Manufacturing Center) uses a special tool to tighten the locking nut. When the incorrect nut is used or a locking Nut is put on incorrectly the strain relief will become loose as described above.

The individual parts shown in **Figure 8** are not available from Agilent parts “SPO” (Support Parts Organization). It is not cost affective to repair the **AC INPUT SAFETY COVER**, a special tool is required to tighten the nut shown in Figure 2.

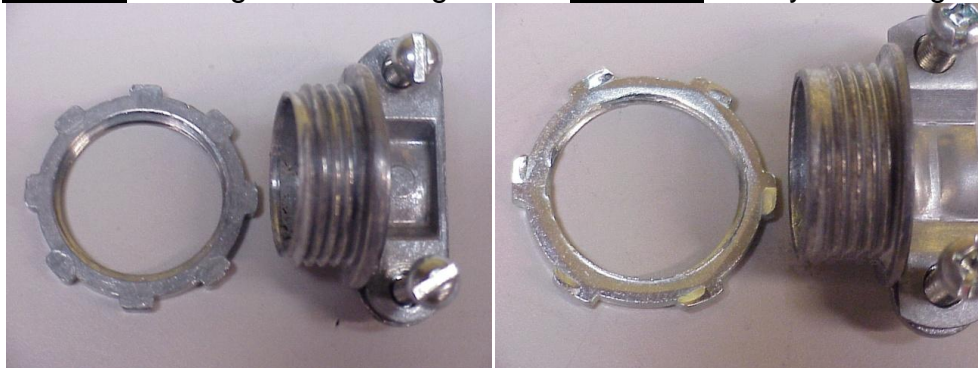
Figure 3 Regal Non locking Nut **Figure 4** Heyco locking Nut

Figures 3 & 5 is representative of a not without locking ribs.

Figures 4 & 6 is representative of a nut with locking ribs.

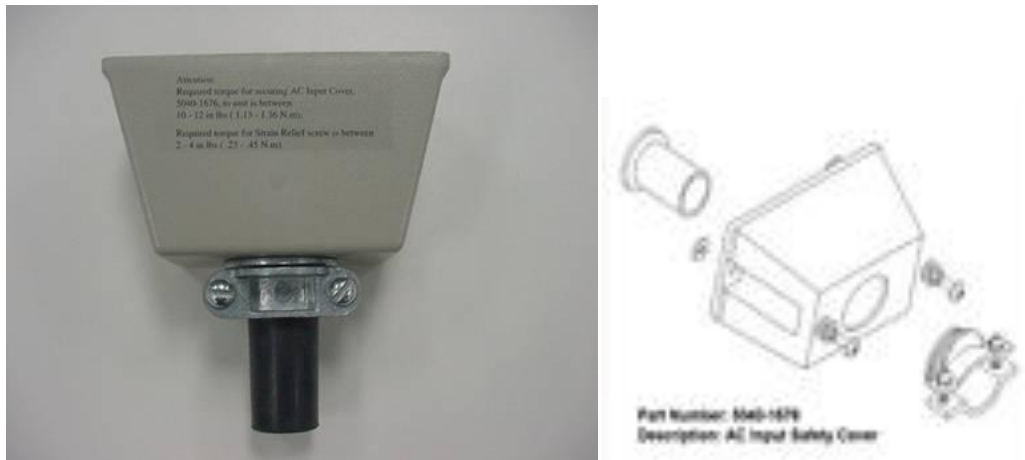
The information below is what is printed on the label shown in **Figure 8**

Required torque for securing AC Input Cover,
5040-1676, to unit is between
10 – 12 in lbs (1.13 – 1.26 N.m).

Required torque for Strain Relief screw is between
tightened using 2inlb torque.

ONLY replace the AC Safety Cover P/N 5040-1676 if the label shown in Figure 8 does not appear on the Safety cover or if the Cover is defective due to described failure, the Safety cover should be replaced at **NO** charge to the customer.
