6673A-07A

S E R V I C E N O T E

6673A DC POWER SUPPLY GPIB CONTROLLED

**Serial Numbers: US36381113/US36381313 & MY41000101/MY41000600 &
SG41000101/SG41000388**

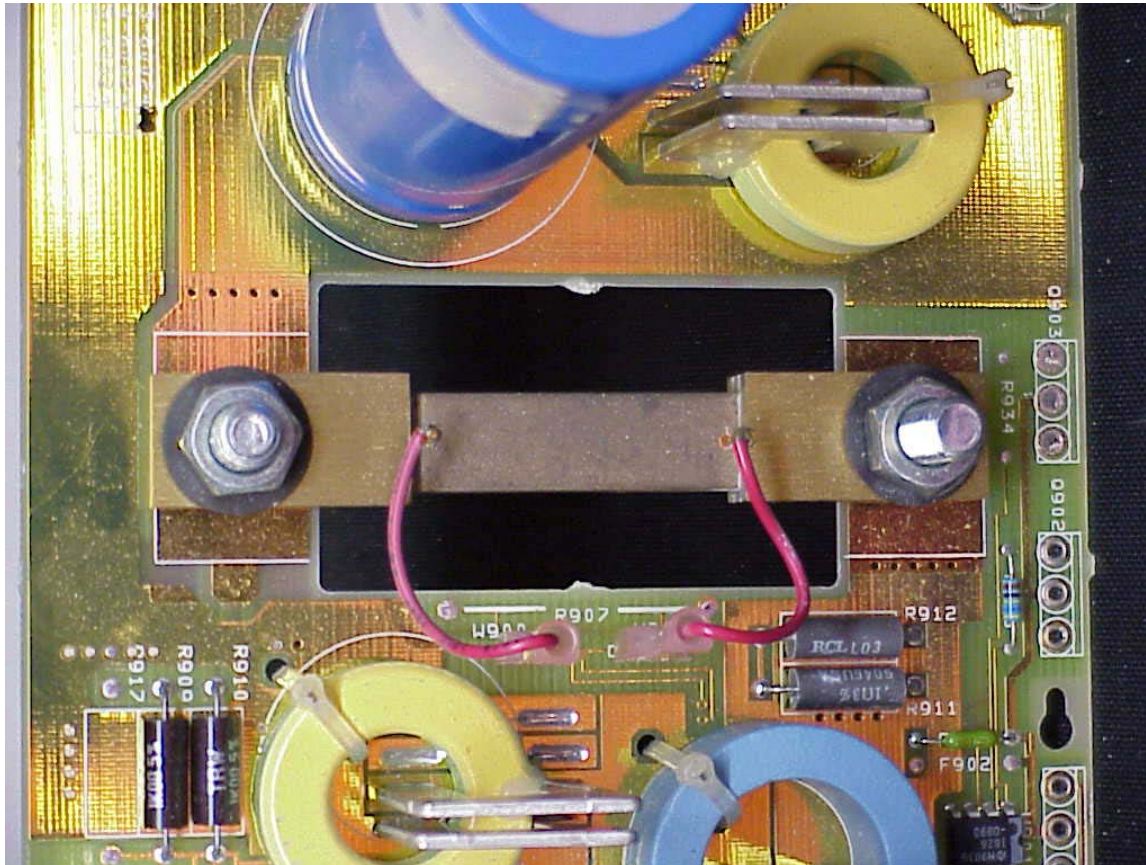
The Current Shunt (Circuit Reference “R907”) may have intermittent sense wires, which may cause Instability of Current regulation, Current read back and Current programming.

When the push-on connectors become intermittent the output current will become unstable. Loose push-on connectors can cause the output current to change dramatically. The current can change from any set current, and may go to the maximum rated output current of the instrument.

This picture shows how the Shunt R907 is connected using the term-crimp connectors.

The Shunt R907 is connected to "W900" & "W901"
