MODIFICATION RECOMMENDED

6673A-10

S E R V I C E N O T E

**6673A DC POWER SUPPLY, 0-35 V, 0-60 A, 2100 W.
GPIB CONTROLLED.**

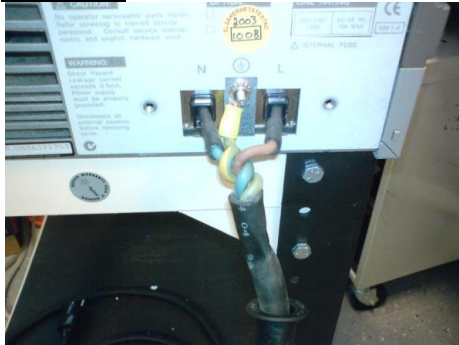
When the incorrect nut is used or a locking Nut is put on incorrectly the strain relief will become loose.

Figure 1 is an example of what happens when the strain relief becomes loose, the line cord becomes twisted. When a heavy line cord is used the strain relief becomes loose very easily, and the line cord cable can rotate freely.

The entire AC INPUT SAFETY COVER P/N 5040-1676 should be replaced.

The line cord should also be securely fastened at a point 6 to 12 inches away from INPUT SAFETY COVER as shown in [Figure 7](#). When this type of strain relief is used the electrical code requires the cord/cable being held by the strain relief be secured. Doing this eliminates the cable or cord from being twisted as shown in [figure 1](#).

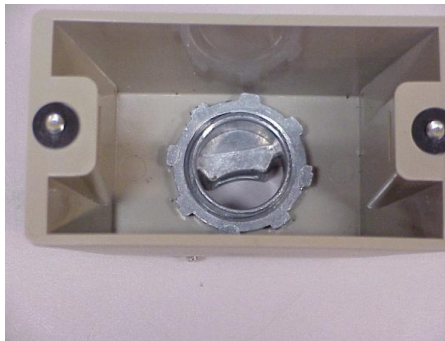
Figure 2 shows the inside of the AC Safety Cover housing the incorrect hardware is shown. It will be very difficult to tighten the strain relief. AMC (Asian Manufacturing Center) uses a special tool to tighten the locking nut. When the incorrect nut is used or a locking Nut is put on incorrectly the strain relief will become loose as described above.

The individual parts shown in [Figure 8](#) are not available from Agilent parts “SPO” (Support Parts Organization). It is not cost affective to repair the AC INPUT SAFETY COVER, a special tool is required to tighten the nut shown in [Figure 2](#).

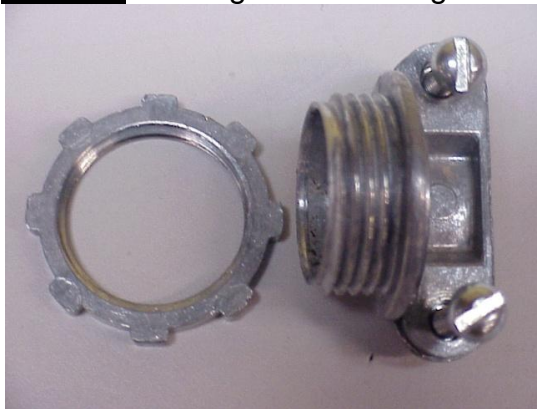
Figure 3 Regal Non locking Nut

Figures 3 & 5 is representative of a not without locking ribs.

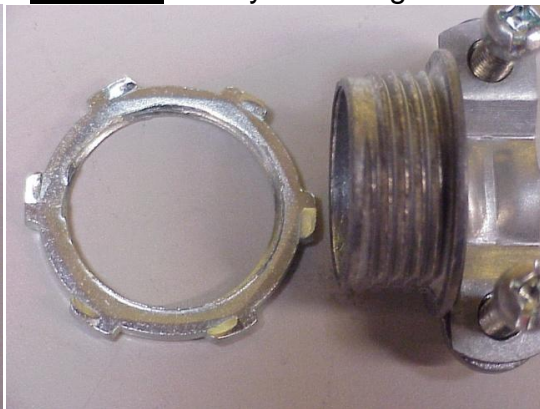
Figure 4 Heyco locking Nut

Figures 4 & 6 is representative of a nut with locking ribs.

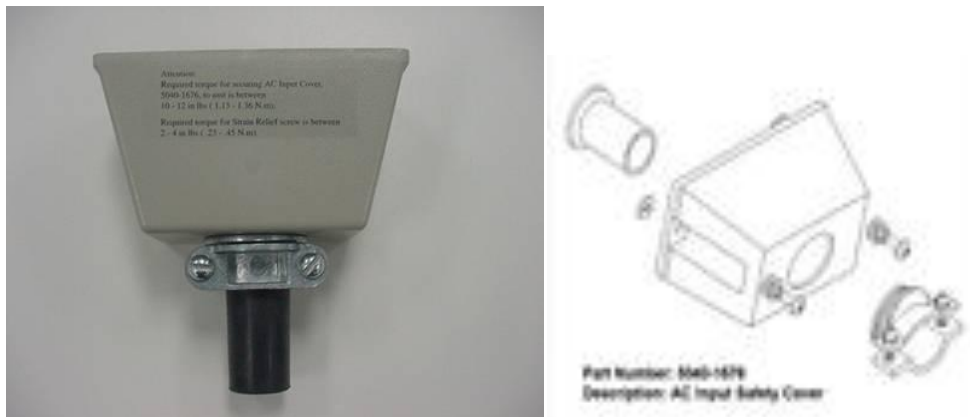
Figure 8

The information below is what is printed on the label shown in [Figure 8](#)

Required torque for securing AC Input Cover,
5040-1676, to unit is between
10 – 12 in lbs (1.13 – 1.26 N.m).

Required torque for Strain Relief screw is between
tightened using 2inlb torque.

ONLY replace the AC Safety Cover P/N 5040-1676 if the label shown in [Figure 8](#) does not appear on the Safety cover or if the Cover is defective due to described failure, the Safety cover should be replaced at **NO** charge to the customer.
