# 6811B-03 <u>SERVICE NOTE</u>

# 6811B AC Source/Analyzer

Serial Numbers: US38390001- US38399999, MY41000101- MY41001051, SG41000101-SG41000175

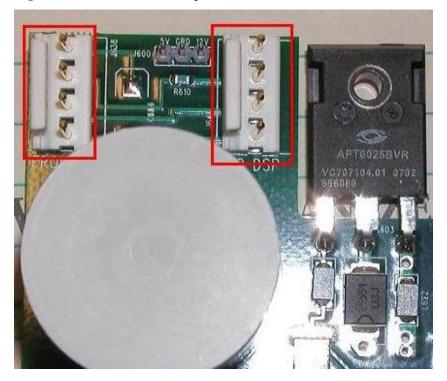
#### Page 3 of 6 Figure 1. A7 Inverter PCA Top View

The first two connector headers are J638 and J646 on the A7 Inverter PCA. They need to be changed to the four pin connector, part number 1253-7410. These connectors should be fairly easy to desolder.

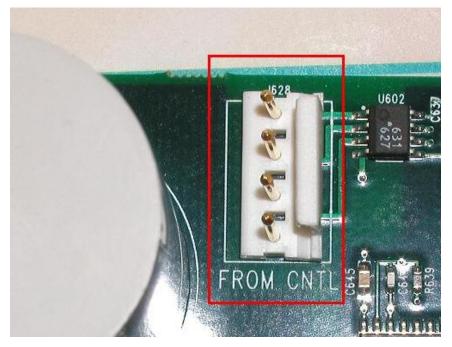
### Page 4 of 6 Figure 3. A7 Inverter PCA Top View

J628 on the A7 Inverter PCA also needs to be changed with part number 1253-7410. This should also be easy to de-solder.

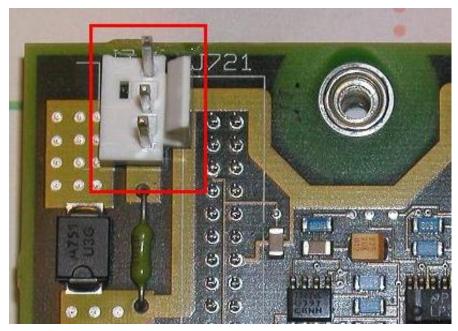
J721 on the A8 DSP assembly must also be changed. This is a three pin connector and should be changed to part number 1253-7460. This connector is hard to de-solder due to it being on top of a ground plane so extra care must be taken in order to avoid damaging the PCA. It is recommended to use solder wick instead of a de-soldering station.
