6813B-06

# <u>SERVICE NOTE</u>

# 6813B AC SOURCE/ANALYZER, 0-300 VRMS,1750 VA, SINGLE-PHASE. GPIB, RS-232.

The **AC INPUT SAFETY COVER** has a strain relief used to secure the AC line cord that may become loose.

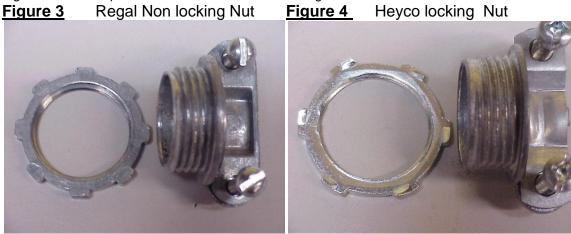
Figures 3 & 5 is representative of a not without locking ribs.

Figure 5 4 & 6 is representative of a nut with locking ribs.

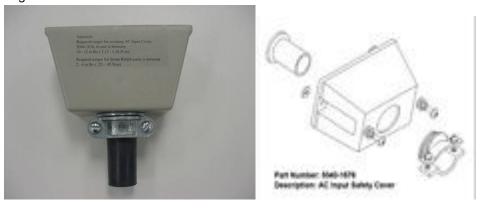
# Figure 8

The information below is what is printed on the label shown in Figure 8

Required torque for securing AC Input Cover, 5040-1676, to unit is between 10 – 12 in lbs (1.13 – 1.26 N.m).

Required torque for Strain Relief screw is between tightened using 2inlb torque.

<u>ONLY</u> replace the AC Safety Cover P/N 5040-1676 if the label shown in Figure 8 does not appear on the Safety cover or if the Cover is defective due to described failure, the Safety cover should be replaced at <u>NO</u> charge to the customer.
