70004A-15-S

S E R V I C E N O T E

HP 70004A MMS Display

Possible Fire Hazard

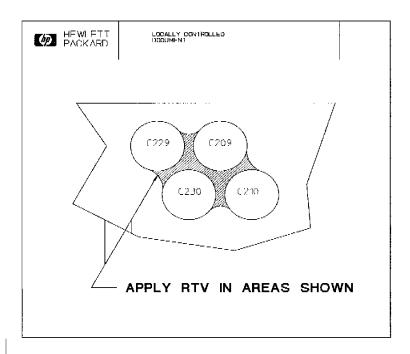
A unique datecode of capacitors has shown indications of leaking a portion of their contained electrolyte onto high voltage lines in the power supply board (part #70004-60040). The first indication of this may be a blown main fuse. To date, 2 out of 394 instruments containing the unique datecode capacitors have exhibited failures. These failures occurred during production heat cycling. Both failures resulted in a blown main fuse.

Replace the 4 power supply capacitors C209, C210, C229, and C230, part number 0180-4595, datecode 47Y01L33, with same part number, any other datecode. Use high power soldering iron (>=40W) with tip temperature at 800 deg F. After removing capacitors clean board with water-based cleaning solution. After new capacitors have been installed, apply RTV (HP P/N 0470-0450) between them for mechanical stablization. (See attached diagram for RTV application process.)
