S E R V I C E N O T E

70100A Power Meter

Modification to Eliminate Loose Reference Oscillator N-type connectors

Page 2 Service Note 70100A-01

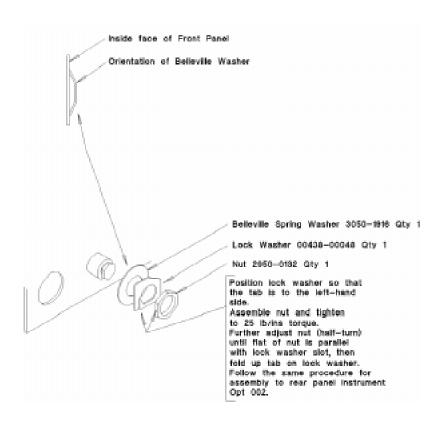
Figure 1

Multiple connections of power sensors to the Reference Oscillator, together with the weight of the sensor, have been causing lateral movement on the connector which has distorted the mounting hole on the front panel. This has in turn allowed the retaining nut to rotate backwards and make the connector even looser. Tightening the nut has fixed the problem in the past but the problem has re-occured in some instances because the front panel hole distortion still exists.

A new fixing mechanism has been introduced which includes a spring washer and a lock washer. If the hole distortion occurs these two washers ensure that the nut remains under tension and cannot rotate. The connector therefore does not come loose. The instrument will need to be stripped down to give access to the rear of the Reference Oscillator connector on the front or rear panel. See Figure 1. for instructions on how to put on the new fixing hardware.
